# Access Compliance Report

## Public Rights-of-Way

### (Curb Ramps)

| Intersection ID: 50596 | Main Street: STREAM_ORCHID_LN | Cross Street: GRAY_WILLOW_RD | Location: SW |

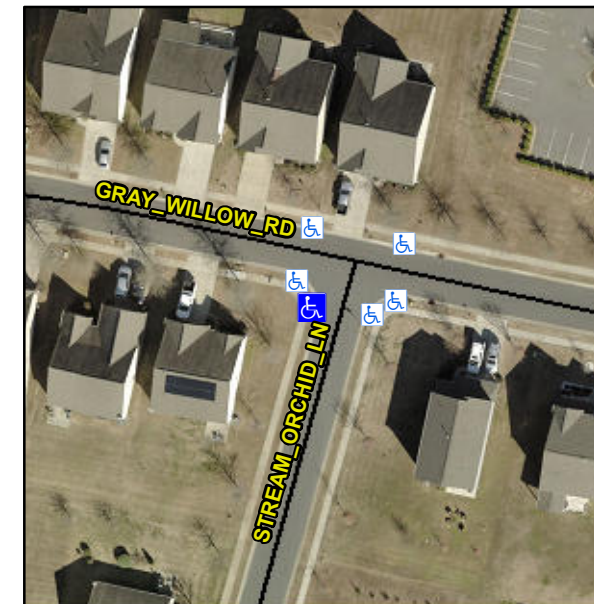
| ADA ID: 7D59CBDD8DE0 | Ramp Type: BlendTrans1 | Initial Pass/Fail: Pass | Overall Compliance: No |
| Severity Score: 5 | | | |

**Not Found, R304.5.4**

| Compliance | Description | Data | Compliance | Description | Data |
|---|---|---|---|---|---|
| Yes | Gutter Ponding? | No | No | Gutter Slope (%) | 7.5 |
| | | | No | Curb Slope (%) | 8.4 |

**Remove & Replace Curb Slope and Extend Ramp. Remove & Replace Gutter.**

Total Cost: \$ 2750.00
