Access Compliance Report

Public Rights-of-Way

(Curb Ramps)

Intersection ID: 30033	Main Street: DILLARD RIDGE DR	Cross Street: SOUTHWIND DR	Location: SE
ADA ID: 7D59F73C4DBB	Ramp Type: PerpDiag	Initial Pass/Fail: Fail	Overall Compliance: No
Codes/Mitigation Info/Possible Solution		Field Measurements/Component Compliance	
Severity Score: 12.5

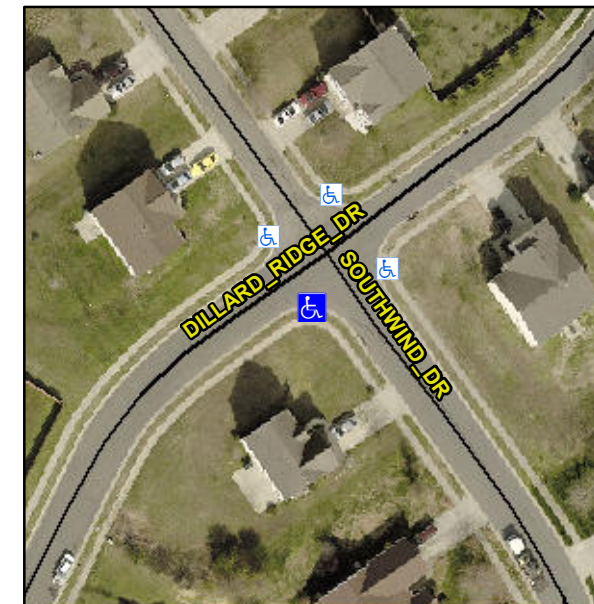
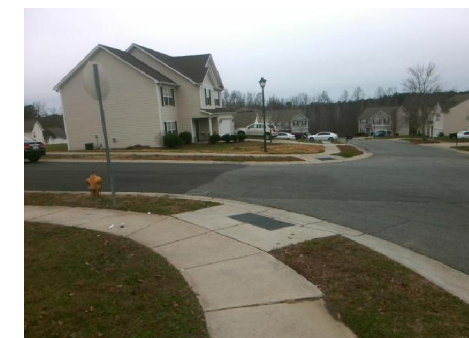
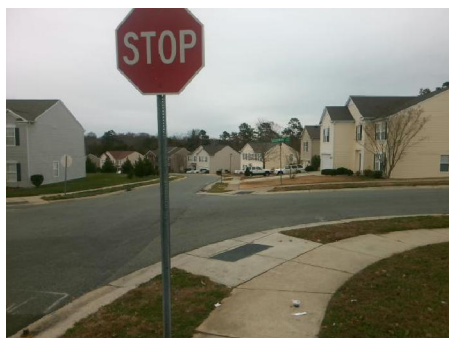
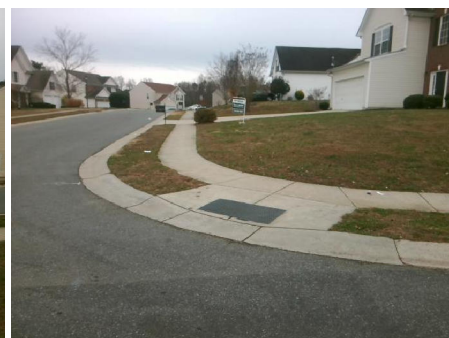
Not Found, R304.2.2

Compliance	Description	Data	Compliance	Description	Data
N/A	Ramp Length (in)	56.0	No	Ramp Slope (%)	10.1
Yes	Ramp Width (in)	48.0	Yes	Ramp XSlope (%)	1.0
N/A	Flare Type LT	N/A	N/A	Flare Type RT	N/A
N/A	Flare Slope LT (%)	N/A	N/A	Flare Slope RT (%)	N/A
N/A	Flare Traversable LT?	N/A	N/A	Flare Traversable RT?	N/A
N/A	Landing Length (in)	N/A	N/A	DWS Provided?	N/A
N/A	Landing Width (in)	N/A	N/A	DWS Contrast?	N/A
N/A	Landing Slope (%)	N/A	N/A	DWS Length (in)	N/A
N/A	Landing X Slope (%)	N/A	N/A	DWS Full Width?	N/A
N/A	Landing Curb? (Y/N)	N/A	N/A	DWS Offset (in)	N/A
N/A	Shared Landing?	N/A			
N/A	Gutter Ponding?	N/A	N/A	Gutter Slope (%)	N/A
N/A	Gutter Lip Ht (in)	N/A	N/A	Gutter X Slope (%)	N/A
N/A	Painted X Walk1?	No	N/A	Painted X Walk2?	No
	X Walk 1 Direction	To NW		X Walk 2 Direction	To N
N/A	X Walk 1 Width (in)	N/A	N/A	X Walk 2 Width (in)	N/A
	X Walk 1 Slope (%)	1.8		X Walk 2 Slope (%)	1.0
	X Walk 1 X Slope (%)	3.8		X Walk 2 X Slope (%)	1.4

N/A	Ramp inside XWalk1?	N/A	N/A	Ramp inside XWalk2?	N/A
	Road Slope (%)	0.4	N/A	Clear Space?	N/A
	Road X Slope (%)	2.0	N/A	Clear Space to XWalk (in)	N/A
N/A	Any Obstructions?	N/A	N/A	Storm Grate/Utility Hazard?	N/A
	Obstruction Type			Storm Grate/Utility Type	
		N/A			N/A
		Yes		Surface Condition? (G/P)	Good

Remove & Replace Curb Ramp With Two New Directional Ramps or Equivalent.
