# Access Compliance Report

## Public Rights-of-Way

### (Curb Ramps)

Intersection ID: 43015	Main Street: BRISTOL_PLACE_CT	Cross Street: SPRINGS_FARM_LN	Location: NW
ADA ID: 7D6981D413B7	Ramp Type: PerpDiag	Initial Pass/Fail: Fail	Overall Compliance: No Severity Score: 13.75

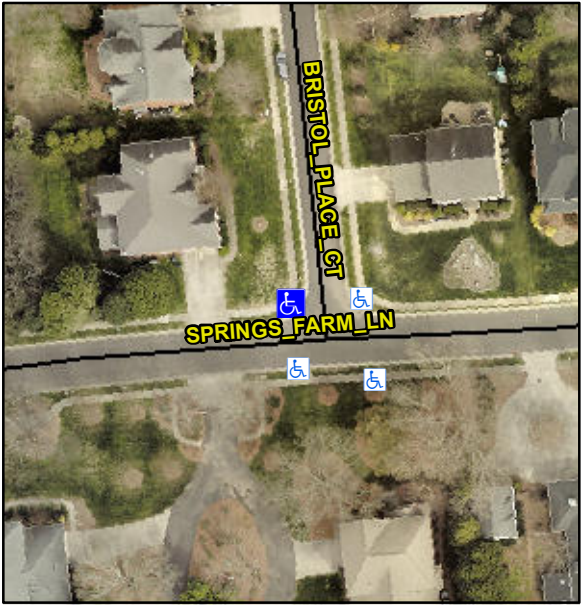
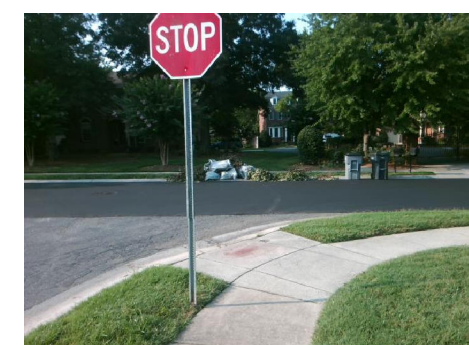
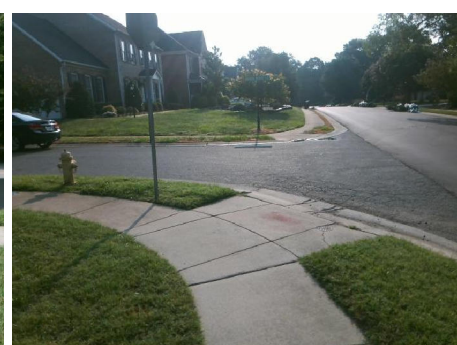
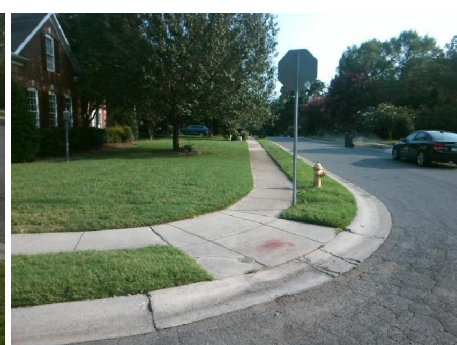
Possible Solutions:		<b>Compliance</b>	<b>Description</b>	<b>Data</b>
	<b>Remove &amp; Replace Curb Ramp With Two New Directional Ramps or Equivalent.</b>		<b>No</b>	Ramp Length (in)	<b>48.0</b>
			<b>Yes</b>	Ramp Width (in)	<b>48.0</b>
			<b>N/A</b>	Flare Type LT	<b>N/A</b>
			<b>N/A</b>	Flare Slope LT (%)	<b>N/A</b>
			<b>N/A</b>	Flare Traversable LT?	<b>N/A</b>
			<b>N/A</b>	Landing Length (in)	<b>N/A</b>
			<b>N/A</b>	Landing Width (in)	<b>N/A</b>
			<b>N/A</b>	Landing Slope (%)	<b>N/A</b>
			<b>N/A</b>	Landing X Slope (%)	<b>N/A</b>
<p>Surveyor Notes:</p> <p><b>N/A</b></p> <p>PROW/ADA:</p> <p><b>Not Found, R304.2.2, R304.5.3</b></p>			<b>N/A</b>	Flare Type RT	<b>N/A</b>
			<b>N/A</b>	Flare Slope RT (%)	<b>N/A</b>
			<b>N/A</b>	Flare Traversable RT?	<b>N/A</b>
			<b>N/A</b>	DWS Provided?	<b>N/A</b>
			<b>N/A</b>	DWS Contrast?	<b>N/A</b>

<b>N/A</b>	DWS Length (in)	<b>N/A</b>
			<b>N/A</b>	DWS Full Width?	<b>N/A</b>
			<b>N/A</b>	DWS Offset (in)	<b>N/A</b>
			<b>N/A</b>	Shared Landing?	<b>N/A</b>
			<b>N/A</b>	Gutter Ponding?	<b>N/A</b>
			<b>N/A</b>	Gutter Lip Ht (in)	<b>N/A</b>
			<b>N/A</b>	Painted X Walk1?	<b>No</b>
				X Walk 1 Direction	<b>To S</b>
			<b>N/A</b>	X Walk 1 Width (in)	<b>N/A</b>
				X Walk 1 Slope (%)	<b>2.8</b>
				X Walk 1 X Slope (%)	<b>1.4</b>
			<b>N/A</b>	Ramp inside XWalk1?	<b>N/A</b>
				Road Slope (%)	<b>0.3</b>
				Road X Slope (%)	<b>5.0</b>
			<b>N/A</b>	Any Obstructions?	<b>N/A</b>
				Obstruction Type	
Total Cost: \$ 3200.00			<b>N/A</b>		<b>N/A</b>
			<b>Yes</b>	Surface Condition? (G/P)	<b>Good</b>
