Access Compliance Report

Public Rights-of-Way

(Curb Ramps)

Intersection ID: 44465	Main Street: AINSWORTH_ST	Cross Street: VALCOURT_RD	Location: SE
ADA ID: 7D6DBC9383E3	Ramp Type: BlendTrans1	Initial Pass/Fail: Fail	Overall Compliance: No
		Severity Score: 8.75

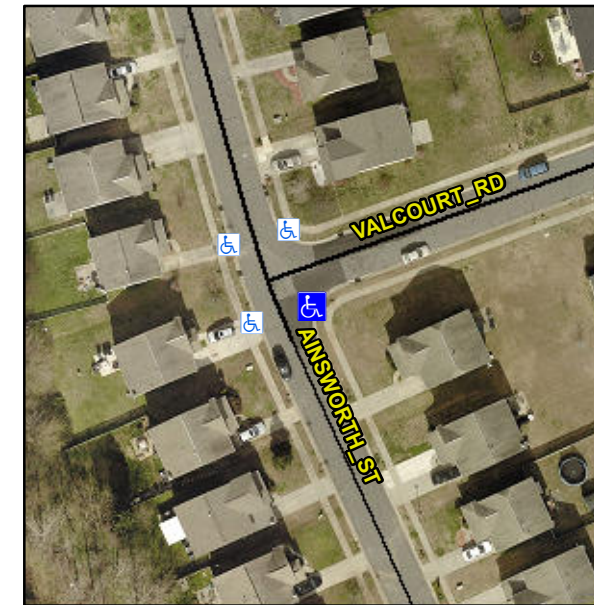
Compliance	Description	Data	Compliance	Description	Data
N/A	Ramp Length (in)	48.0	Yes	BlendTrans Slope (%)	4.2
No	Ramp Width (in)	40.5	Yes	BlendTrans XSlope (%)	0.5
N/A	Flare Type LT	N/A	N/A	Flare Type RT	N/A
N/A	Flare Slope LT (%)	N/A	N/A	Flare Slope RT (%)	N/A
N/A	Flare Traversable LT?	N/A	N/A	Flare Traversable RT?	N/A
N/A	Landing Length (in)	N/A	N/A	DWS Provided?	N/A
N/A	Landing Width (in)	N/A	N/A	DWS Contrast?	N/A
N/A	Landing Slope (%)	N/A	N/A	DWS Length (in)	N/A
N/A	Landing X Slope (%)	N/A	N/A	DWS Full Width?	N/A
N/A	Landing Curb? (Y/N)	N/A	N/A	DWS Offset (in)	N/A
N/A	Shared Landing?	N/A			
N/A	Gutter Ponding?	N/A	N/A	Gutter Slope (%)	N/A
N/A	Gutter Lip Ht (in)	N/A	N/A	Gutter X Slope (%)	N/A
N/A	Painted X Walk1?	No	N/A	Painted X Walk2?	No
	X Walk 1 Direction	To N		X Walk 2 Direction	To W
	X Walk 1 Width (in)	N/A		X Walk 2 Width (in)	N/A
	X Walk 1 Slope (%)	1.1		X Walk 2 Slope (%)	2.3
	X Walk 1 X Slope (%)	1.5		X Walk 2 X Slope (%)	2.0

N/A	Ramp inside XWalk1?	N/A	N/A	Ramp inside XWalk2?	N/A
	Road Slope (%)	0.3		Clear Space?	N/A
	Road X Slope (%)	0.6	N/A	Clear Space to XWalk (in)	N/A
N/A	Any Obstructions?	N/A	N/A	Storm Grate/Utility Hazard?	N/A
	Obstruction Type			Storm Grate/Utility Type	
		N/A			N/A
			Yes	Surface Condition? (G/P)	Good
			No	Curb Slope (%)	11.5

Possible Solutions:

Remove & Replace Curb Ramp With Two New Directional Ramps or Equivalent.
