Access Compliance Report

Public Rights-of-Way

(Curb Ramps)

| Intersection ID: 18428 | Main Street: MCLAUGHLIN_DR | Cross Street: PINEBOROUGH_RD | Location: W |

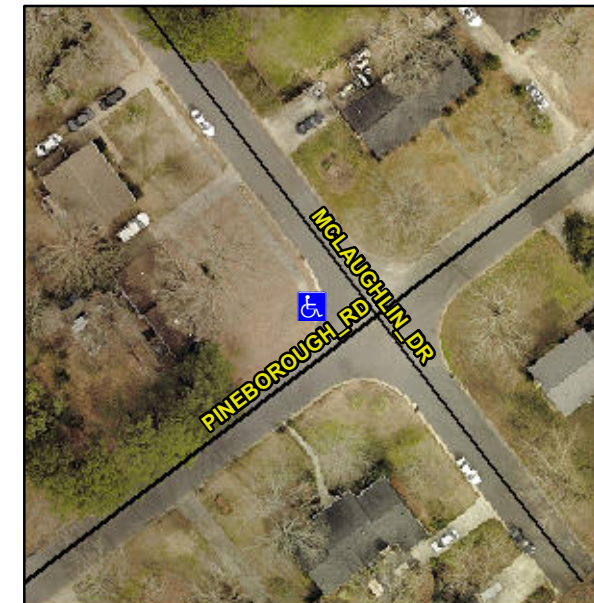
| Compliance | Description | Data | Compliance | Description | Data |
|---|---|---|---|---|---|
| N/A | Ramp Length (in) | 47.0 | No | Ramp Slope (%) | 9.7 |
| Yes | Ramp Width (in) | 48.0 | No | Ramp XSlope (%) | 9.3 |

Remove & Replace Curb Ramp With Two New Directional Ramps or Equivalent.

R304.2.2, R304.5.3
