## **Access Compliance Report Public Rights-of-Way** (Curb Ramps)

Intersection ID: 20090 Main Street: OLD\_PINEVILLE\_RD **Cross Street: LAKEMIST\_DR** Location: NW **Overall Compliance: No** ADA ID: 7D8242F5A94E Ramp Type: PerpDiag Initial Pass/Fail: Fail Severity Score: 21.25

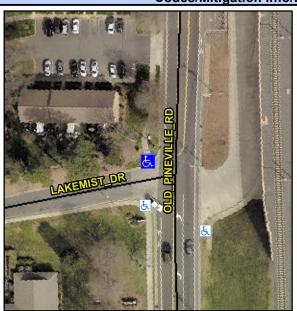
Field Measurements/Component Compliance								
	Compliance Description		Data	Compliance Description		Data		
	N/A	Ramp Length (in)	59.5	No	Ramp Slope (%)	8.6		
	No	Ramp Width (in)	47.5	Yes	Ramp XSlope (%)	1.9		
	N/A	Flare Type LT	N/A	N/A	Flare Type RT	N/A		
	N/A	Flare Slope LT (%)	N/A	N/A	Flare Slope RT (%)	N/A		
	N/A	Flare Traversable LT?	N/A	N/A	Flare Traversable RT?	N/A		
	N/A	Landing Length (in)	N/A	N/A	DWS Provided?	N/A		
	N/A	Landing Width (in)	N/A	N/A	DWS Contrast?	N/A		
	N/A	Landing Slope (%)	N/A	N/A	DWS Length (in)	N/A		
	N/A	Landing X Slope (%)	N/A	N/A	DWS Full Width?	N/A		
	N/A	Landing Curb? (Y/N)	N/A	N/A	DWS Offset (in)	N/A		
	N/A	Shared Landing?	N/A					
	N/A	Gutter Ponding?	N/A	N/A	Gutter Slope (%)	N/A		
	N/A	Gutter Lip Ht (in)	N/A	N/A	Gutter X Slope (%)	N/A		
	N/A	Painted X Walk1?	No	N/A	Painted X Walk2?	No		
		X Walk 1 Direction	To S		X Walk 2 Direction	To E		
	N/A	X Walk 1 Width (in)	N/A	N/A	X Walk 2 Width (in)	N/A

X Walk 1 Slope (%)	1.4		X Walk 2 Slope (%)	5.5		
		X Walk 1 X Slope (%)	2.1		X Walk 2 X Slope (%)	1.1		
	N/A	Ramp inside XWalk1?	N/A	N/A	Ramp inside XWalk2?	N/A		
		Road Slope (%)	2.6	N/A	Clear Space?	N/A		
		Road X Slope (%)	5.7	N/A	Clear Space to XWalk (in)	N/A		
	N/A	Any Obstructions?	N/A	N/A	Storm Grate/Utility Hazard?	N/A		
		Obstruction Type			Storm Grate/Utility Type			
			N/A			N/A		
				Yes	Surface Condition? (G/P)	Good		
T 10 10

Possible Solution							
Possible Solutions:							
Remove & Replace Curb Ramp With Two New Directional Ramps or Equivalent.							
Surveyor Notes:	ı						
N/A	! !						
PROW/ADA:	i						
Not Found, R304.5.1, R304.2.2	1						
	ı
