Access Compliance Report Public Rights-of-Way (Curb Ramps)

Intersection ID: 9129 Main Street: N_GRAHAM_ST Cross Street: NORRIS_AV Location: NW **Overall Compliance: No** ADA ID: 7D99810EE84C Ramp Type: Perp Initial Pass/Fail: Fail Severity Score: 21.25

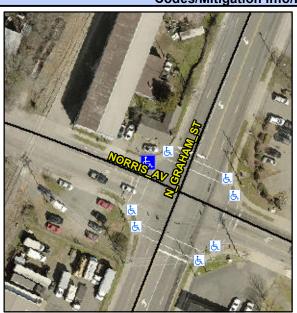
Field Measurements/Component Compliance						
Comp	liance Description	Data	Comp	liance	Description	Data
N/A	Ramp Length (in)	71.0	Yes	Ramp	Slope (%)	6.8
No	Ramp Width (in)	47.0	No	Ramp	XSlope (%)	5.8
N/A	Flare Type LT	N/A	N/A	Flare	Type RT	N/A
N/A	Flare Slope LT (%)	N/A	N/A	Flare	Slope RT (%)	N/A
N/A	Flare Traversable LT?	N/A	N/A	Flare	Traversable RT?	N/A
N/A	Landing Length (in)	N/A	N/A	DWS	Provided?	N/A
N/A	Landing Width (in)	N/A	N/A	DWS	Contrast?	N/A
N/A	Landing Slope (%)	N/A	N/A	DWS	Length (in)	N/A
N/A	Landing X Slope (%)	N/A	N/A	DWS	Full Width?	N/A
N/A	Landing Curb? (Y/N)	N/A	N/A	DWS	Offset (in)	N/A
N/A	Shared Landing?	N/A				
N/A	Gutter Ponding?	N/A	N/A	Gutte	r Slope (%)	N/A
N/A	Gutter Lip Ht (in)	N/A	N/A	Gutte	r X Slope (%)	N/A
N/A	Painted X Walk1?	Yes	N/A	Paint	ed X Walk2?	N/A
	X Walk 1 Direction	To SW		X Wa	lk 2 Direction	N/A
N/A	X Walk 1 Width (in)	119.0	N/A	X Wa	lk 2 Width (in)	N/A
	X Walk 1 Slope (%)	2.5		X Wa	lk 2 Slope (%)	N/A

X Walk 1 X Slope (%)	6.7		X Wa	lk 2 X Slope (%)	N/A
N/A	Ramp inside XWalk1?	Yes	N/A	Ram	inside XWalk2?	N/A
	Road Slope (%)	N/A	N/A	Clear	Space?	N/A
	Road X Slope (%)	N/A	N/A	Clear	Space to XWalk (in)	N/A
N/A	Any Obstructions?	N/A	N/A	Storn	n Grate/Utility Hazard?	N/A
	Obstruction Type			Storn	n Grate/Utility Type	
		N/A				N/A
			Yes	Surfa	ce Condition? (G/P)	Good

1 CCCIDIC CCIGNICIT	
Possible Solutions:	Co
Remove & Replace Entire Ramp.	N/A
	No
	N/A
	N/A
	N/A
	N/A
Surveyor Notes:	N/A
N/A	N/A
	N/A
	N/A
	N/A
PROW/ADA:	N/A
Not Found, R304.5.1, R304.5.3	N/A
	N/A
	N//
	N//

1850.00
