# Access Compliance Report

## Public Rights-of-Way

### (Curb Ramps)

Intersection ID: 30505	Main Street: HARVEST_TIME_CT	Cross Street: PLANTERS_ESTATES_DR	Location: SW
ADA ID: 7D9A573085D2	Ramp Type: PerpDiag	Initial Pass/Fail: Fail	Overall Compliance: No
Severity Score: 21.25			
Codes/Mitigation Info/Possible Solution		Field Measurements/Component Compliance

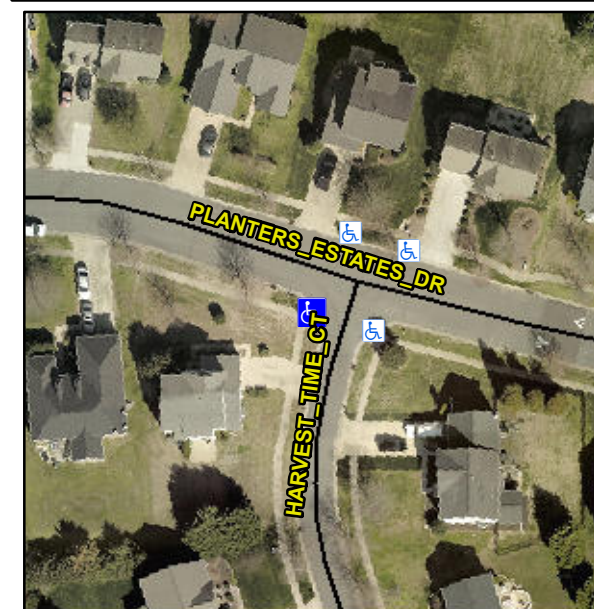
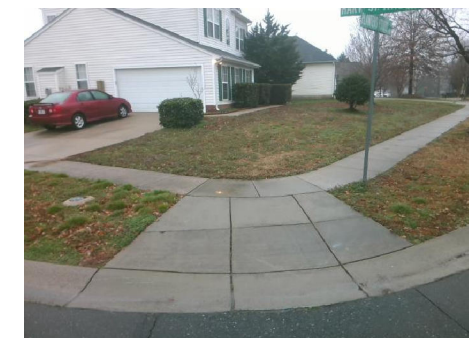
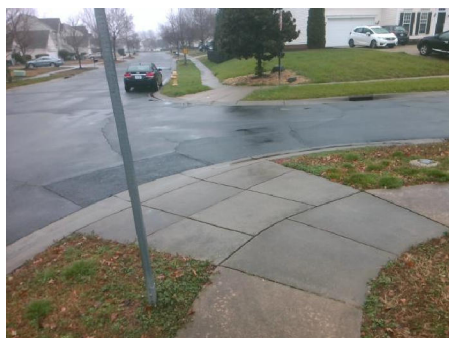
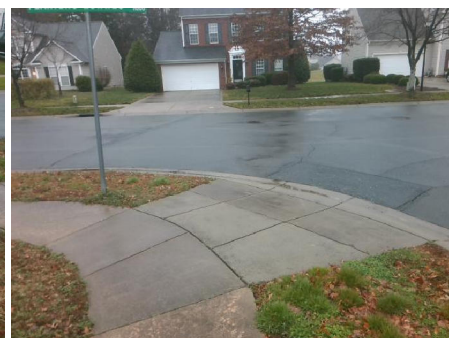
Compliance	Description	Data	Compliance	Description	Data
N/A	Ramp Length (in)	42.0	No	Ramp Slope (%)	11.0
No	Ramp Width (in)	43.5	Yes	Ramp XSlope (%)	0.4
N/A	Flare Type LT	N/A	N/A	Flare Type RT	N/A
N/A	Flare Slope LT (%)	N/A	N/A	Flare Slope RT (%)	N/A
N/A	Flare Traversable LT?	N/A	N/A	Flare Traversable RT?	N/A
N/A	Landing Length (in)	N/A	N/A	DWS Provided?	N/A
N/A	Landing Width (in)	N/A	N/A	DWS Contrast?	N/A
N/A	Landing Slope (%)	N/A	N/A	DWS Length (in)	N/A
N/A	Landing X Slope (%)	N/A	N/A	DWS Full Width?	N/A
N/A	Landing Curb? (Y/N)	N/A	N/A	DWS Offset (in)	N/A
N/A	Shared Landing?	N/A			
N/A	Gutter Ponding?	N/A	N/A	Gutter Slope (%)	N/A
N/A	Gutter Lip Ht (in)	N/A	N/A	Gutter X Slope (%)	N/A
N/A	Painted X Walk1?	No	N/A	Painted X Walk2?	No
	X Walk 1 Direction	To SE		X Walk 2 Direction	To NE
N/A	X Walk 1 Width (in)	N/A	N/A	X Walk 2 Width (in)	N/A
	X Walk 1 Slope (%)	1.8		X Walk 2 Slope (%)	2.9
	X Walk 1 X Slope (%)	2.1		X Walk 2 X Slope (%)	1.0

N/A	Ramp inside XWalk1?	N/A	N/A	Ramp inside XWalk2?	N/A
	Road Slope (%)	2.7	N/A	Clear Space?	N/A
	Road X Slope (%)	4.5	N/A	Clear Space to XWalk (in)	N/A
N/A	Any Obstructions?	N/A	N/A	Storm Grate/Utility Hazard?	N/A
	Obstruction Type			Storm Grate/Utility Type	
		N/A			N/A
			Yes	Surface Condition? (G/P)	Good

Possible Solutions:

**Remove & Replace Curb Ramp With Two New Directional Ramps or Equivalent.**

**R304.5.1, R304.2.2**
