## **Access Compliance Report Public Rights-of-Way** (Curb Ramps)

Intersection ID: 27440 Main Street: BALLANTYNE\_COMMONS\_PY Cross Street: DOWINGTON\_DR Location: NE

ADA ID: 7DA9A8AB15DF Ramp Type: Perp Initial Pass/Fail: Fail **Overall Compliance: No Severity Score:** 17.5

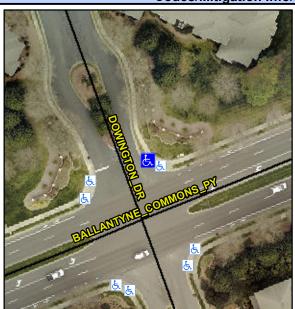
**DOWINGTON DR** Street 1 Name Stop Condition-Street 2 StopSign Street 2 Name N/A Stop Condition-Street 1 N/A Possible Solutions: Remove & Replace Entire Ramp. Surveyor Notes: N/A

PROW/ADA: Not Found, R304.5.1 Total Cost: 1850.00

| Field Measurements/Component Compliance | | | | | | |
|---|---|---|---|---|---|---|
| | No | Ramp Width (in) | 35.0 | Yes | Ramp XSlope (%) | 0.8 |
