Access Compliance Report

Public Rights-of-Way

(Curb Ramps)

Intersection ID: 11685	Main Street: E_19TH_ST	Cross Street: SEIGLE_AV	Location:	N
ADA ID: 7DB45CF58A7D	Ramp Type: Perp	Initial Pass/Fail: Fail	Overall Compliance: No	Severity Score: 10

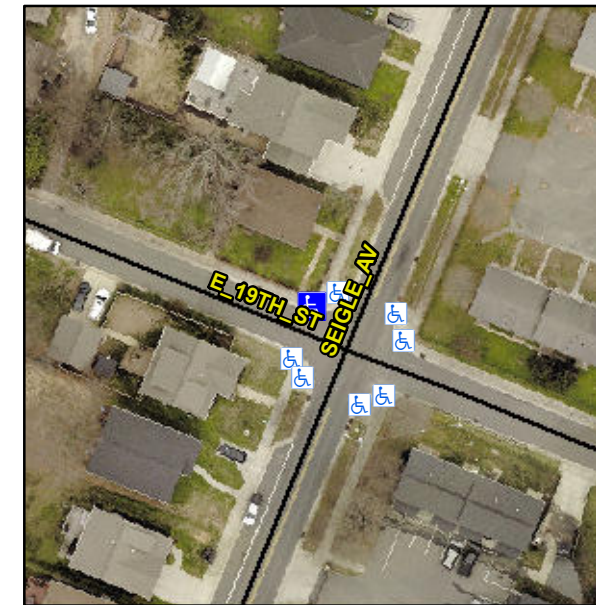
Compliance	Description	Data	Compliance	Description	Data
N/A	Ramp Length (in)	60.0	Yes	Ramp Slope (%)	6.1
No	Ramp Width (in)	47.5	No	Ramp XSlope (%)	4.7
N/A	Flare Type LT	N/A	N/A	Flare Type RT	N/A
N/A	Flare Slope LT (%)	N/A	N/A	Flare Slope RT (%)	N/A
N/A	Flare Traversable LT?	N/A	N/A	Flare Traversable RT?	N/A
N/A	Landing Length (in)	N/A	N/A	DWS Provided?	N/A
N/A	Landing Width (in)	N/A	N/A	DWS Contrast?	N/A
N/A	Landing Slope (%)	N/A	N/A	DWS Length (in)	N/A
N/A	Landing X Slope (%)	N/A	N/A	DWS Full Width?	N/A
N/A	Landing Curb? (Y/N)	N/A	N/A	DWS Offset (in)	N/A
N/A	Shared Landing?	N/A			
N/A	Gutter Ponding?	N/A	N/A	Gutter Slope (%)	N/A
N/A	Gutter Lip Ht (in)	N/A	N/A	Gutter X Slope (%)	N/A
N/A	Painted X Walk1?	No	N/A	Painted X Walk2?	N/A
	X Walk 1 Direction	To SW		X Walk 2 Direction	N/A
N/A	X Walk 1 Width (in)	N/A	N/A	X Walk 2 Width (in)	N/A
	X Walk 1 Slope (%)	4.5		X Walk 2 Slope (%)	N/A
	X Walk 1 X Slope (%)	7.1		X Walk 2 X Slope (%)	N/A

N/A	Ramp inside XWalk1?	N/A	N/A	Ramp inside XWalk2?	N/A
	Road Slope (%)	N/A	N/A	Clear Space?	N/A
	Road X Slope (%)	N/A	N/A	Clear Space to XWalk (in)	N/A
N/A	Any Obstructions?	N/A	N/A	Storm Grate/Utility Hazard?	N/A
	Obstruction Type			Storm Grate/Utility Type	
		N/A			N/A
			Yes	Surface Condition? (G/P)	Good

Remove & Replace Entire Ramp.

R304.5.1, R304.5.3

Total Cost: \$ 1850.00
