Access Compliance Report

Public Rights-of-Way

(Curb Ramps)

Intersection ID: N/A	Main Street: COLONEL FRANCIS J BEATTY PARK DR	Cross Street: PARKGATE DR	Location: SE
ADA ID: 7DD24FEF5ED4	Ramp Type: PerpDiag	Initial Pass/Fail: Fail	Overall Compliance: No
		Severity Score: 22.5

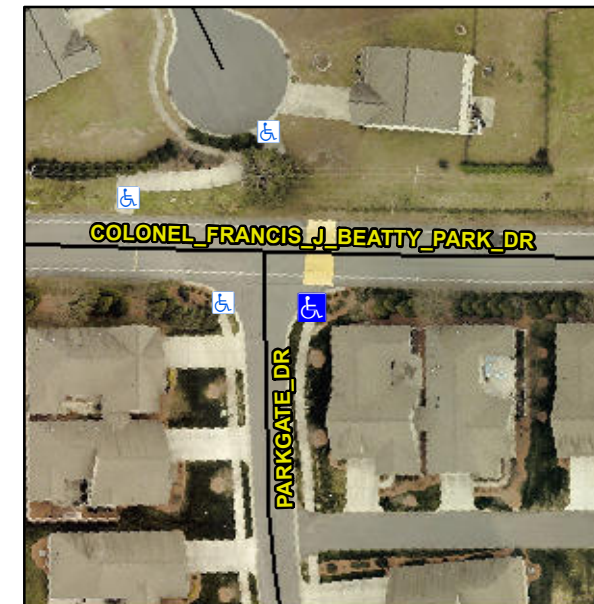
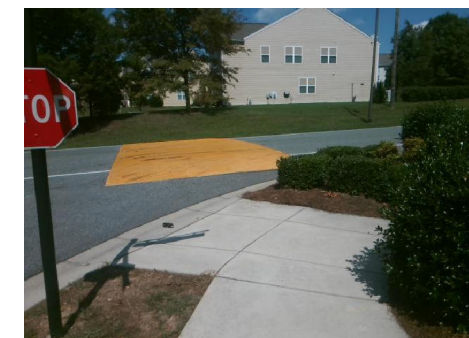
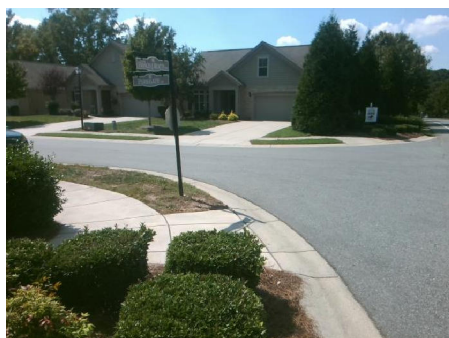
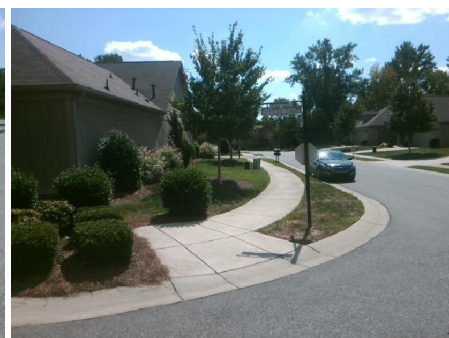
Not Found, R304.5.1, R304.2.2, R304.5.3

Compliance	Description	Data	Compliance	Description	Data
N/A	Ramp Length (in)	48.0	No	Ramp Slope (%)	8.4
No	Ramp Width (in)	40.0	No	Ramp XSlope (%)	4.8
N/A	Flare Type LT	N/A	N/A	Flare Type RT	N/A
N/A	Flare Slope LT (%)	N/A	N/A	Flare Slope RT (%)	N/A
N/A	Flare Traversable LT?	N/A	N/A	Flare Traversable RT?	N/A
N/A	Landing Length (in)	N/A	N/A	DWS Provided?	N/A
N/A	Landing Width (in)	N/A	N/A	DWS Contrast?	N/A
N/A	Landing Slope (%)	N/A	N/A	DWS Length (in)	N/A
N/A	Landing X Slope (%)	N/A	N/A	DWS Full Width?	N/A
N/A	Landing Curb? (Y/N)	N/A	N/A	DWS Offset (in)	N/A
N/A	Shared Landing?	N/A			
N/A	Gutter Ponding?	N/A	N/A	Gutter Slope (%)	N/A
N/A	Gutter Lip Ht (in)	N/A	N/A	Gutter X Slope (%)	N/A
N/A	Painted X Walk1?	No	N/A	Painted X Walk2?	No
	X Walk 1 Direction	To N		X Walk 2 Direction	To W
N/A	X Walk 1 Width (in)	N/A	N/A	X Walk 2 Width (in)	N/A
	X Walk 1 Slope (%)	7.0		X Walk 2 Slope (%)	0.3
	X Walk 1 X Slope (%)	1.4		X Walk 2 X Slope (%)	1.9

Remove & Replace Curb Ramp With Two New Directional Ramps or Equivalent.
