Access Compliance Report

Public Rights-of-Way

(Curb Ramps)

Intersection ID: 14567	Main Street: E_TREMONT_AV	Cross Street: LYNDHURST_AV	Location: W
ADA ID: 7DD98F544F21	Ramp Type: Directional1	Initial Pass/Fail: Fail	Overall Compliance: No
			Severity Score: 21.25

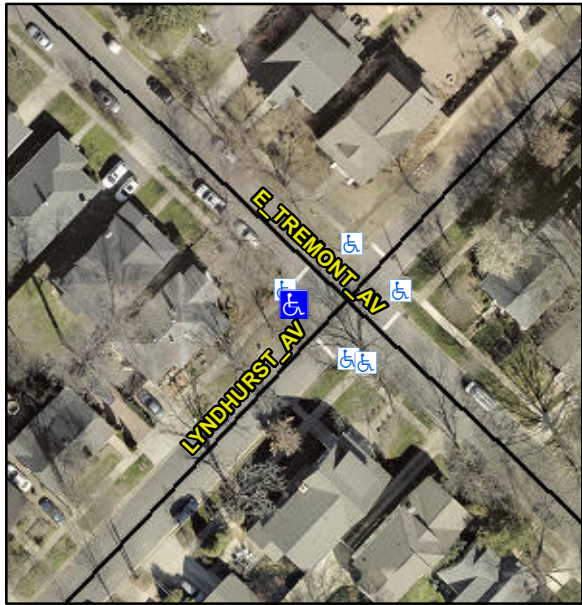
Possible Solutions:		Compliance	Description	Data	Compliance	Description	Data
	Remove & Replace Entire Ramp.		N/A	Ramp Length (in)	60.0	N/A	Grade Break?	N/A
			No	Ramp Width (in)	46.0	N/A	Grade Break Slope (%)	0.0
			No	Ramp Slope (%)	9.6	N/A	Grade Break XSlope (%)	0.0
			Yes	Ramp XSlope (%)	1.8			
			N/A	Flare Type LT	N/A	N/A	Flare Type RT	N/A
			N/A	Flare Slope LT (%)	N/A	N/A	Flare Slope RT (%)	0.0
			N/A	Flare Traversable LT?	N/A	N/A	Flare Traversable RT?	N/A
	Surveyor Notes:		N/A	Landing Length (in)	0.0	N/A	DWS Provided?	N/A
			N/A	Landing Width (in)	0.0	N/A	DWS Contrast?	N/A
		N/A	Landing Slope (%)	0.0	N/A	DWS Length (in)	N/A	
		N/A	Landing X Slope (%)	0.0	N/A	DWS Full Width?	N/A	
PROW/ADA:		N/A	Landing Curb? (Y/N)	N/A	N/A	DWS Offset LT (in)	N/A	
R304.5.1, R304.2.2		N/A	Shared Landing?	N/A	N/A	DWS Offset RT (in)	N/A

N/A	Gutter Ponding?	0.0	N/A	Gutter Slope (%)	N/A	
		N/A	Gutter Lip Ht (in)	1.0	N/A	Gutter X Slope (%)	N/A	
		N/A	Painted X Walk1?	No		Road Slope (%)	0.0	
			X Walk 1 Direction	To SE		Road X Slope (%)	1.2	
			X Walk 1 Width (in)	N/A		Clear Space?	N/A	
			X Walk 1 Slope (%)	0.0	N/A	Clear Space to XWalk (in)	N/A	
			X Walk 1 X Slope (%)	1.2	N/A	Storm Grate/Utility Hazard?	N/A	
		N/A	Ramp inside XWalk1?	N/A		Storm Grate/Utility Type		
		N/A	Any Obstructions?	N/A			N/A	
			Obstruction Type		Yes	Surface Condition? (G/P)	Good	
					N/A	Curb Slope (%)	0.9	
Street 1 Name		LYNDHURST AV						
Stop Condition-Street 1		StopSign						
Street 2 Name		N/A						
Stop Condition-Street 2		N/A						
Total Cost:		\$ 1600.00
