## Access Compliance Report Public Rights-of-Way (Curb Ramps)

Intersection ID: 32087	ntersection ID: 32087 Main Street: JERPOINT_ABBY_DR		Cross	Cross Street: SLADE_CASTLE_CT				Location:	NE
ADA ID: 7DDD848DEFB3 Ramp Type: PerpDiag		Initial	Initial Pass/Fail: Fail Overall Compliance: No				o Severity Score:	58.75	
Codes/Mitigation Info/Possible Solution				Field Measurements/Component Compliance					
	PPF	Possible Solutions:		Compliance Description			Data Compliance Description		
		Remove & Replace Curb Ramp	With	N/A	Ramp Length (in)	47.5	No	Ramp Slope (%)	13.7
		Two New Directional Ramps o		No	Ramp Width (in)	36.0	No	Ramp XSlope (%)	12.8
		Equivalent.		N/A	Flare Type LT	N/A	N/A	Flare Type RT	N/A
				N/A	Flare Slope LT (%)	N/A	N/A	Flare Slope RT (%)	N/A
				N/A	Flare Traversable LT?	N/A	N/A	Flare Traversable RT?	N/A
	Real Pro-			N/A	Landing Length (in)	N/A	N/A	DWS Provided?	N/A
		Surveyor Notes:		N/A	Landing Width (in)	N/A	N/A	DWS Contrast?	N/A
		N/A		N/A	Landing Slope (%)	N/A	N/A	DWS Length (in)	N/A

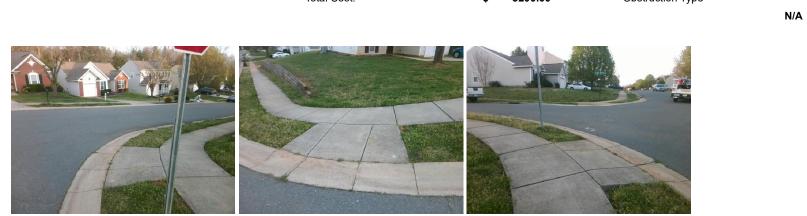
SLADE Q	ASTLE_GT			N/A	Landing X Slope (%)	N/A	N/A	DWS Full Width?	N/A
	Sto d			N/A	Landing Curb? (Y/N)	N/A	N/A	DWS Offset (in)	N/A
				N/A	Shared Landing?	N/A			
	5 10	PROW/ADA:		N/A	Gutter Ponding?	N/A	N/A	Gutter Slope (%)	N/A
	1 Charles	R304.5.1, R304.2.2, R304.5.3		N/A	Gutter Lip Ht (in)	N/A	N/A	Gutter X Slope (%)	N/A
		·····,····,····,·····,·····,····		N/A	Painted X Walk1?	No	N/A	Painted X Walk2?	No
				X Walk 1 Direction	To W		X Walk 2 Direction	To S	
			N/A	X Walk 1 Width (in)	N/A	N/A	X Walk 2 Width (in)	N/A	
Street 1 Name JERPOINT ABBY DR					X Walk 1 Slope (%)	2.3		X Walk 2 Slope (%)	9.9
Stop Condition-Street 2	None				X Walk 1 X Slope (%)	12.3		X Walk 2 X Slope (%)	6.1
Street 2 Name SLAD	E CASTLE CT			N/A	Ramp inside XWalk1?	N/A	N/A	Ramp inside XWalk2?	N/A
Stop Condition-Street 1	StopSign				Road Slope (%)	10.8	N/A	Clear Space?	N/A
	_				Road X Slope (%)	5.1	N/A	Clear Space to XWalk (in)	N/A

N/A	Any Obstructions?	N/A	N/A	Storm Grate/Utility Hazard?	N/A
		Total Cost: \$	3200.00		Obstruction Type			Storm Grate/Utility Type	
						N/A			N/A
