## Access Compliance Report Public Rights-of-Way (Curb Ramps)

Intersection ID: 17596 Main Street: WATER\_OAK\_RD Cross Street: N\_SHARON\_AMITY\_RD Location: SW

ADA ID: 7DDF4C4474B4 Ramp Type: BlendTrans2 Initial Pass/Fail: Fail Overall Compliance: No Severity Score: 8.75

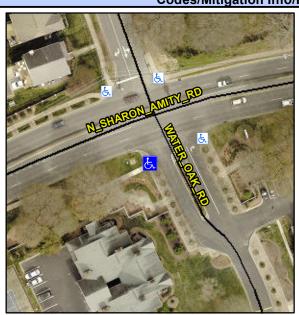
Data	Compliance Description		Data
N/A	Ramp Length (in)	48.0	Yes	BlendTrans Slope (%)	2.1
No	Ramp Width (in)	45.0	Yes	BlendTrans XSlope (%)	0.8
N/A	Flare Type LT	N/A	N/A	Flare Type RT	N/A
N/A	Flare Slope LT (%)	N/A	N/A	Flare Slope RT (%)	N/A
N/A	Flare Traversable LT?	N/A	N/A	Flare Traversable RT?	N/A
N/A	Landing Length (in)	N/A	N/A	DWS Provided?	N/A
N/A	Landing Width (in)	N/A	N/A	DWS Contrast?	N/A
N/A	Landing Slope (%)	N/A	N/A	DWS Length (in)	N/A
N/A	Landing X Slope (%)	N/A	N/A	DWS Full Width?	N/A
N/A	Landing Curb? (Y/N)	N/A	N/A	DWS Offset (in)	N/A
N/A	Shared Landing?	N/A			
N/A	Gutter Ponding?	N/A	N/A	Gutter Slope (%)	N/A
N/A	Gutter Lip Ht (in)	N/A	N/A	Gutter X Slope (%)	N/A
N/A	Painted X Walk1?	No	N/A	Painted X Walk2?	No
	X Walk 1 Direction	To NE		X Walk 2 Direction	To NW
	X Walk 1 Width (in)	N/A		X Walk 2 Width (in)	N/A
	X Walk 1 Slope (%)	1.4		X Walk 2 Slope (%)	3.9
	X Walk 1 X Slope (%)	0.8		X Walk 2 X Slope (%)	1.7

N/A	Ramp inside XWalk1?	N/A	N/A	Ramp inside XWalk2?	N/A
	Road Slope (%)	2.1		Clear Space?	N/A
	Road X Slope (%)	0.5	N/A	Clear Space to XWalk (in)	N/A
N/A	Any Obstructions?	N/A	N/A	Storm Grate/Utility Hazard?	N/A
	Obstruction Type			Storm Grate/Utility Type	
		N/A			N/A
			Yes	Surface Condition? (G/P)	Good
ALC: NO			N/A	Curb Slope (%)	3.9

Remove & Replace Curb Ramp With Two New Directional Ramps or Equivalent.
