# Access Compliance Report

## Public Rights-of-Way

| Intersection ID: 3254 | Main Street: HARRINGHAM_LN | Cross Street: SPRING_PARK_DR | Location: NW |
| ADA ID: 7DE3BB1054E0 | Ramp Type: Perp | Initial Pass/Fail: Fail | Overall Compliance: No |

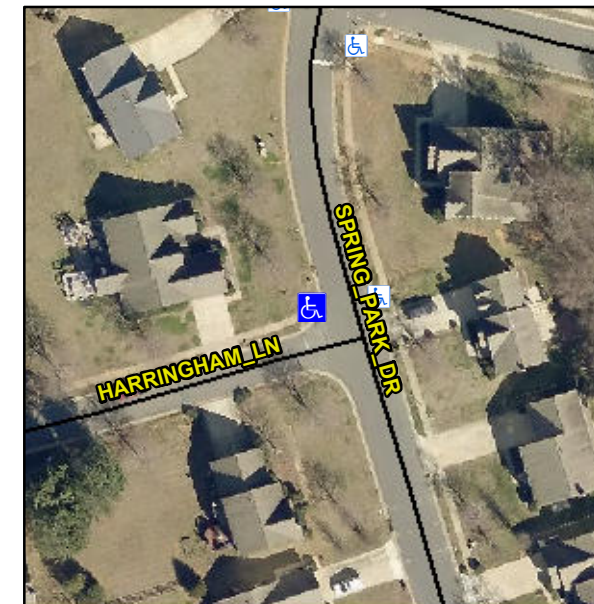
| | | Severity Score: 30 | |

**Not Found, R304.5.1, R304.5.3**

| Compliance | Description | Data | Compliance | Description | Data |
|---|---|---|---|---|---|
| No | Ramp Width (in) | 35.0 | No | Ramp XSlope (%) | 5.5 |

Possible Solutions:

**Remove & Replace Entire Ramp.**

Total Cost: \$ 1850.00
