Access Compliance Report Public Rights-of-Way (Curb Ramps)

Intersection ID: 10011488 Main Street: SHAMROCK_DR Cross Street: N/A Location: SW

ADA ID: 7DF49EEB6255 Ramp Type: Perp Initial Pass/Fail: Fail Overall Compliance: No Severity Score: 21.25

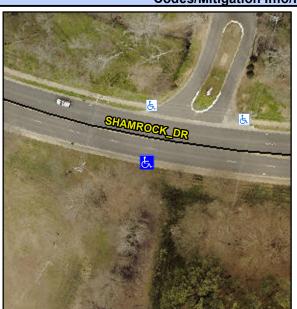
Compl	iance Description	Data	Compl	liance	Description	Data
N/A	Ramp Length (in)	60.0	No	Ram	Slope (%)	10.4
No	Ramp Width (in)	41.0	Yes	Ram	XSlope (%)	0.2
N/A	Flare Type LT	N/A	N/A	Flare	Type RT	N/A
N/A	Flare Slope LT (%)	N/A	N/A	Flare	Slope RT (%)	N/A
N/A	Flare Traversable LT?	No	N/A	Flare	Traversable RT?	No
N/A	Landing Length (in)	N/A	N/A	DWS	Provided?	N/A
N/A	Landing Width (in)	N/A	N/A	DWS Contrast?		N/A
N/A	Landing Slope (%)	N/A	N/A	DWS	Length (in)	N/A
N/A	Landing X Slope (%)	N/A	N/A	DWS	Full Width?	N/A
N/A	Landing Curb? (Y/N)	N/A	N/A	DWS	Offset (in)	N/A
N/A	Shared Landing?	N/A				
N/A	Gutter Ponding?	N/A	N/A	Gutter Slope (%)		N/A
N/A	Gutter Lip Ht (in)	N/A	N/A	Gutter X Slope (%)		N/A
N/A	Painted X Walk1?	No	N/A	Painted X Walk2?		N/A
	X Walk 1 Direction	To N		X Wa	lk 2 Direction	N/A
N/A	X Walk 1 Width (in)	N/A	N/A	X Walk 2 Width (in)		N/A
	X Walk 1 Slope (%)	0.1		X Wa	lk 2 Slope (%)	N/A
	X Walk 1 X Slope (%)	1.4		X Wa	lk 2 X Slope (%)	N/A

N/A	Ramp inside XWalk1?	N/A	N/A	Ram	o inside XWalk2?	N/A
	Road Slope (%)	N/A	N/A	Clear	Space?	N/A
	Road X Slope (%)	N/A	N/A	Clea	Space to XWalk (in)	N/A
N/A	Any Obstructions?	N/A	N/A	Storn	n Grate/Utility Hazard?	N/A
	Obstruction Type		l	Storn	n Grate/Utility Type	
		N/A				N/A
			Yes	Surfa	ce Condition? (G/P)	Good

<u> </u>	1 CCCIDIC CCIALICII	
£	Possible Solutions:	<u>c</u>
	Remove & Replace Entire Ramp.	N
	•	N
		N
		N
is.		N
2		N
Ē	Surveyor Notes:	N
	N/A	N
		N
		N
		N
	PROW/ADA:	N
É	Not Found, R304.5.1, R304.2.2	N
ě		N
10 M		
e.		N
		N
