# Access Compliance Report

## Public Rights-of-Way

### (Curb Ramps)

| Intersection ID: 10020374 | Main Street: BALLANTYNE_CORPORATE_PL | Cross Street: N/A | Location: SE |

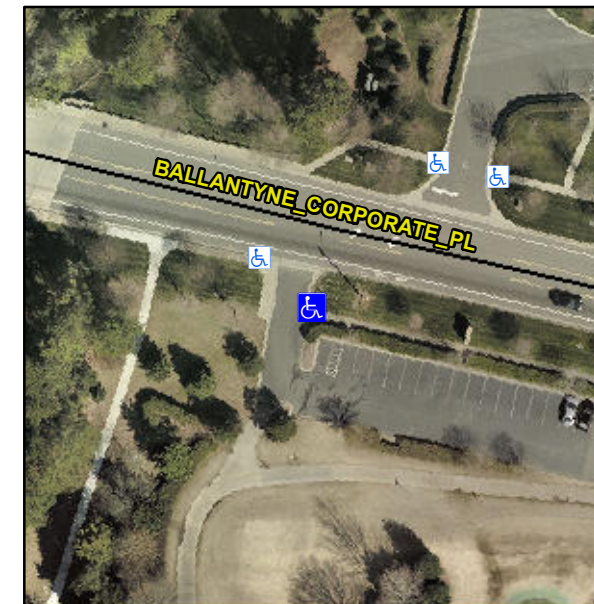
| ADA ID: 7DF4A0D04EAF | Ramp Type: Perp | Initial Pass/Fail: Fail | Overall Compliance: No |
| | | Severity Score: 22.5 | |

**R304.5.1, R304.2.2**

| Compliance | Description | Data | Compliance | Description | Data |
|---|---|---|---|---|---|
| N/A | Ramp Length (in) | 59.0 | No | Ramp Slope (%) | 10.3 |
| No | Ramp Width (in) | 47.5 | Yes | Ramp XSlope (%) | 2.8 |

Possible Solutions:

**Remove & Replace Entire Ramp.**

Total Cost: \$ 1850.00
