# Access Compliance Report

## Public Rights-of-Way

### (Curb Ramps)

Intersection ID: 14585	Main Street: RUBINE_ST	Cross Street: W_TYVOLA_RD	Location: SW
ADA ID: 7DF8D9844BC0	Ramp Type: Perp	Initial Pass/Fail: Fail	Overall Compliance: No
		Severity Score: 42.5

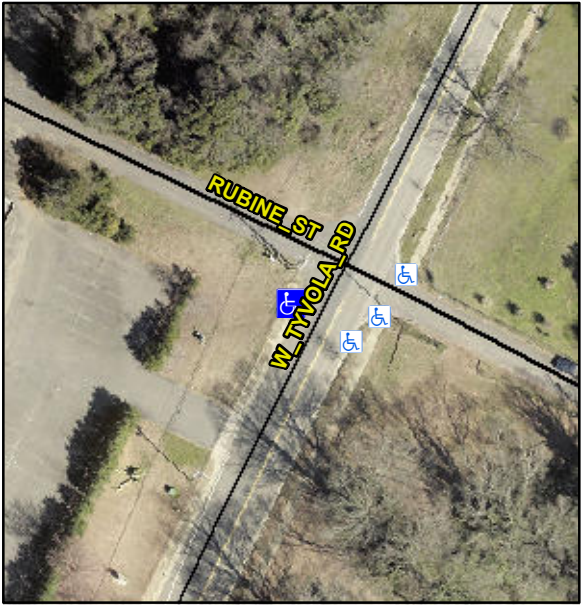
Possible Solutions:		<b>Compliance</b>	<b>Description</b>	<b>Data</b>
	<b>Remove &amp; Replace Entire Ramp.</b>		<b>No</b>	Ramp Length (in)	60.0
			<b>No</b>	Ramp Width (in)	34.0
			<b>N/A</b>	Flare Type LT	N/A
			<b>N/A</b>	Flare Slope LT (%)	N/A
			<b>N/A</b>	Flare Traversable LT?	N/A
			<b>N/A</b>	Landing Length (in)	N/A
			<b>N/A</b>	Landing Width (in)	N/A
			<b>N/A</b>	Landing Slope (%)	N/A
			<b>N/A</b>	Landing X Slope (%)	N/A
<p>Surveyor Notes:</p> <p><b>N/A</b></p> <p>PROW/ADA:</p> <p><b>Not Found, R304.5.1, R304.2.2</b></p>			<b>N/A</b>	Flare Type RT	N/A
			<b>N/A</b>	Flare Slope RT (%)	N/A
			<b>N/A</b>	Flare Traversable RT?	N/A
			<b>N/A</b>	DWS Provided?	N/A
			<b>N/A</b>	DWS Contrast?	N/A
			<b>N/A</b>	DWS Length (in)	N/A
			<b>N/A</b>	DWS Full Width?	N/A
			<b>N/A</b>	DWS Offset (in)	N/A
			<b>N/A</b>	Gutter Ponding?	N/A
