# Access Compliance Report

## Public Rights-of-Way

### (Curb Ramps)

Intersection ID: 45179	Main Street: ELDON_DR	Cross Street: MAPLEHURST DR	Location: NW
ADA ID: 7E0CBF7EED94	Ramp Type: Perp	Initial Pass/Fail: Pass	Overall Compliance: No
Codes/Mitigation Info/Possible Solution			Severity Score: 25
			Field Measurements/Component Compliance

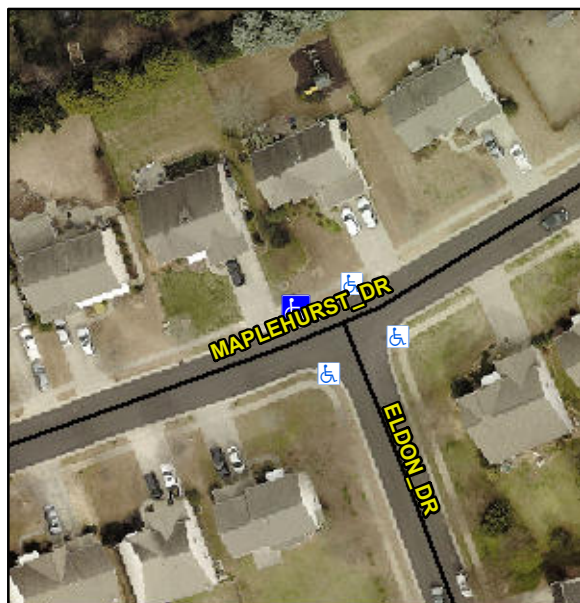
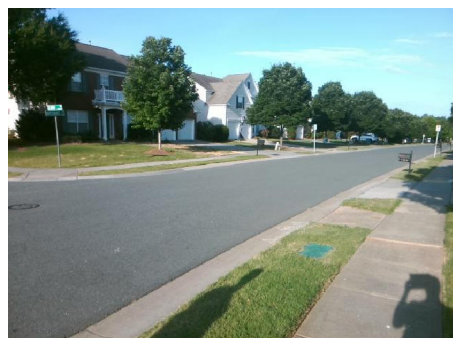
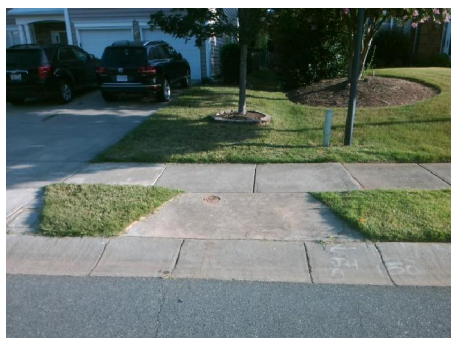
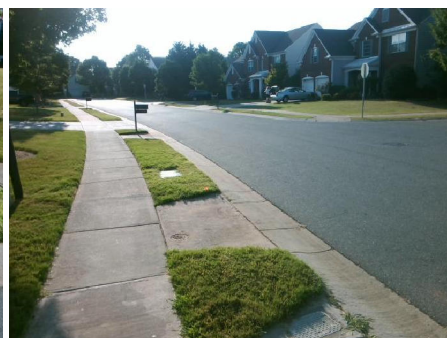
Compliance	Description	Data	Compliance	Description	Data
N/A	Ramp Length (in)	47.0	Yes	Ramp Slope (%)	5.2
Yes	Ramp Width (in)	67.0	Yes	Ramp XSlope (%)	1.1
N/A	Flare Type LT	Sloped	N/A	Flare Type RT	N/A
N/A	Flare Slope LT (%)	3.3	N/A	Flare Slope RT (%)	5.2
N/A	Flare Traversable LT?	No	N/A	Flare Traversable RT?	No
No	Landing Length (in)	N/A	No	DWS Provided?	No
No	Landing Width (in)	N/A	N/A	DWS Contrast?	No
No	Landing Slope (%)	N/A	N/A	DWS Length (in)	N/A
No	Landing X Slope (%)	N/A	N/A	DWS Full Width?	No
N/A	Landing Curb? (Y/N)	No	N/A	DWS Offset (in)	N/A
N/A	Shared Landing?	No			
Yes	Gutter Ponding?	No	No	Gutter Slope (%)	6.0
Yes	Gutter Lip Ht (in)	0.0	Yes	Gutter X Slope (%)	1.0
N/A	Painted X Walk1?	No	N/A	Painted X Walk2?	N/A
	X Walk 1 Direction	To SE		X Walk 2 Direction	N/A
N/A	X Walk 1 Width (in)	N/A	N/A	X Walk 2 Width (in)	N/A
	X Walk 1 Slope (%)	2.4		X Walk 2 Slope (%)	N/A
	X Walk 1 X Slope (%)	0.8		X Walk 2 X Slope (%)	N/A

N/A	Ramp inside XWalk1?	N/A	N/A	Ramp inside XWalk2?	N/A
	Road Slope (%)	N/A	N/A	Clear Space?	Yes
	Road X Slope (%)	N/A	N/A	Clear Space to XWalk (in)	N/A
Yes	Any Obstructions?	No	Yes	Storm Grate/Utility Hazard?	No
	Obstruction Type			Storm Grate/Utility Type	
		N/A			N/A
			Yes	Surface Condition? (G/P)	Good

**Remove & Replace Entire Ramp.  
Remove & Replace Gutter.**

**Not Found, R304.2.1, R304.2.2-Perp,  
R304.3.2-Para, R304.5.3, R305,  
R304.5.4**
