Access Compliance Report

Public Rights-of-Way (Curb Ramps)

Intersection ID: 51510	Main Street: KENILWORTH_AV	Cross Street: PEARL_PARK_WY	Location: NW
ADA ID: 7E1D762CF725	Ramp Type: Directional1	Initial Pass/Fail: Fail	Overall Compliance: No
		Severity Score: 12.5

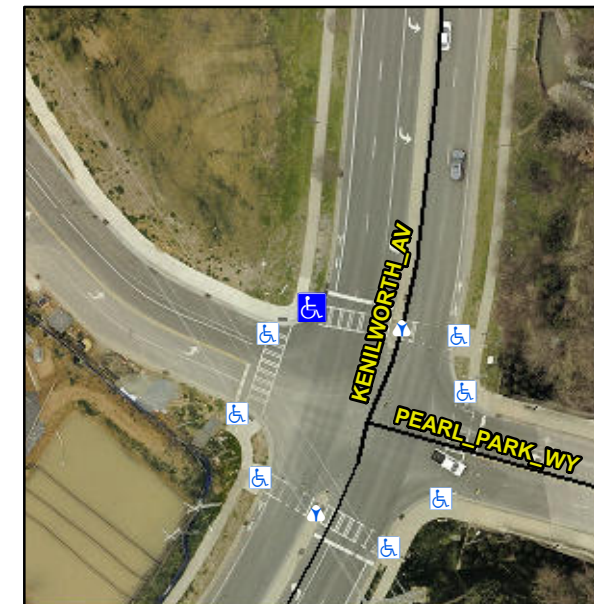
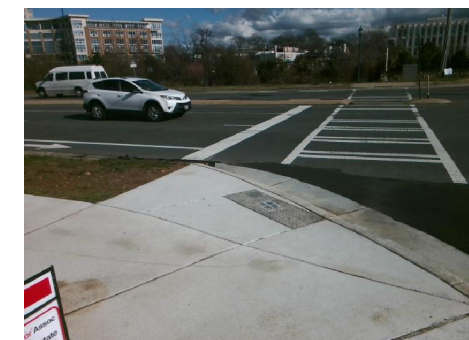
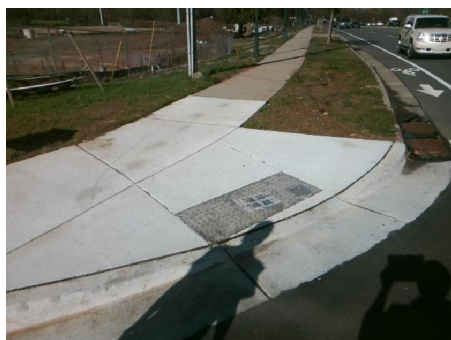
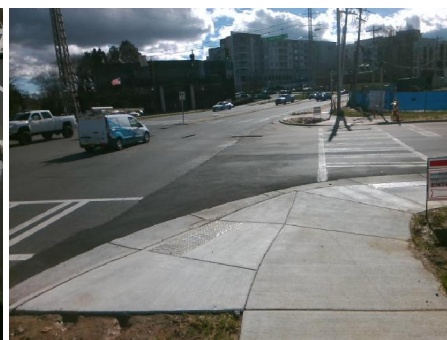
Compliance	Description	Data	Compliance	Description	Data
N/A	Ramp Length (in)	55.0	N/A	Grade Break?	N/A
Yes	Ramp Width (in)	60.0	N/A	Grade Break Slope (%)	0.0
No	Ramp Slope (%)	11.5	N/A	Grade Break XSlope (%)	0.0
Yes	Ramp XSlope (%)	0.6			
N/A	Flare Type LT	N/A	N/A	Flare Type RT	N/A
N/A	Flare Slope LT (%)	N/A	N/A	Flare Slope RT (%)	0.0
N/A	Flare Traversable LT?	N/A	N/A	Flare Traversable RT?	N/A
N/A	Landing Length (in)	0.0	N/A	DWS Provided?	N/A
N/A	Landing Width (in)	0.0	N/A	DWS Contrast?	N/A
N/A	Landing Slope (%)	0.0	N/A	DWS Length (in)	N/A
N/A	Landing X Slope (%)	0.0	N/A	DWS Full Width?	N/A
N/A	Landing Curb? (Y/N)	N/A	N/A	DWS Offset LT (in)	N/A
N/A	Shared Landing?	N/A	N/A	DWS Offset RT (in)	N/A
N/A	Gutter Ponding?	0.0	N/A	Gutter Slope (%)	N/A
N/A	Gutter Lip Ht (in)	0.0	N/A	Gutter X Slope (%)	N/A
N/A	Painted X Walk1?	Yes		Road Slope (%)	2.1
	X Walk 1 Direction	To SE		Road X Slope (%)	1.6
	X Walk 1 Width (in)	112.0		Clear Space?	N/A

X Walk 1 Slope (%)	2.1	N/A	Clear Space to XWalk (in)	N/A
	X Walk 1 X Slope (%)	1.6	N/A	Storm Grate/Utility Hazard?	N/A
N/A	Ramp inside XWalk1?	Yes		Storm Grate/Utility Type	
N/A	Any Obstructions?	N/A			N/A
	Obstruction Type		Yes	Surface Condition? (G/P)	Good
			N/A	Curb Slope (%)	7.2

Remove & Replace Entire Ramp.
