Access Compliance Report

Public Rights-of-Way

(Curb Ramps)

Intersection ID: 10033765	Main Street: OXFORD COMMONS DR	Cross Street: N/A	Location:	N
ADA ID: 7E1FB2CA89A4	Ramp Type: Perp	Initial Pass/Fail: Fail	Overall Compliance: No	Severity Score: 10
Codes/Mitigation Info/Possible Solution		Field Measurements/Component Compliance

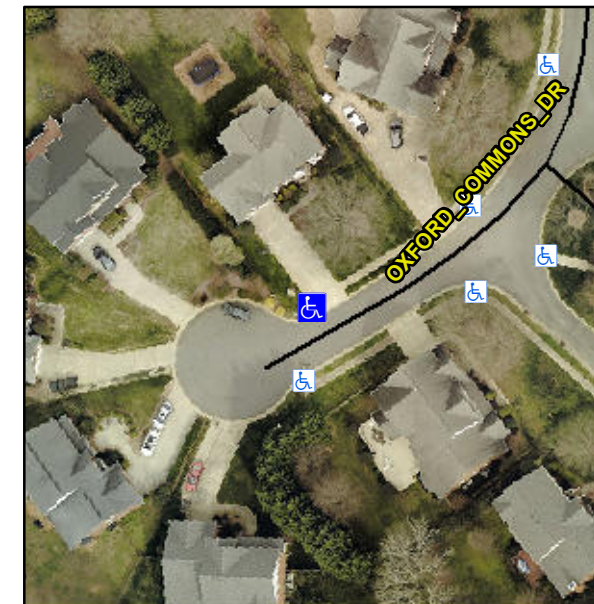
Compliance	Description	Data	Compliance	Description	Data
N/A	Ramp Length (in)	46.0	Yes	Ramp Slope (%)	6.2
No	Ramp Width (in)	46.0	No	Ramp XSlope (%)	2.4
N/A	Flare Type LT	N/A	N/A	Flare Type RT	N/A
N/A	Flare Slope LT (%)	N/A	N/A	Flare Slope RT (%)	N/A
N/A	Flare Traversable LT?	N/A	N/A	Flare Traversable RT?	N/A
N/A	Landing Length (in)	N/A	N/A	DWS Provided?	N/A
N/A	Landing Width (in)	N/A	N/A	DWS Contrast?	N/A
N/A	Landing Slope (%)	N/A	N/A	DWS Length (in)	N/A
N/A	Landing X Slope (%)	N/A	N/A	DWS Full Width?	N/A
N/A	Landing Curb? (Y/N)	N/A	N/A	DWS Offset (in)	N/A
N/A	Shared Landing?	N/A			
N/A	Gutter Ponding?	N/A	N/A	Gutter Slope (%)	N/A
N/A	Gutter Lip Ht (in)	N/A	N/A	Gutter X Slope (%)	N/A
N/A	Painted X Walk1?	No	N/A	Painted X Walk2?	N/A
	X Walk 1 Direction	To S		X Walk 2 Direction	N/A
N/A	X Walk 1 Width (in)	N/A	N/A	X Walk 2 Width (in)	N/A
	X Walk 1 Slope (%)	5.0		X Walk 2 Slope (%)	N/A
	X Walk 1 X Slope (%)	0.3		X Walk 2 X Slope (%)	N/A

N/A	Ramp inside XWalk1?	N/A	N/A	Ramp inside XWalk2?	N/A
	Road Slope (%)	N/A	N/A	Clear Space?	N/A
	Road X Slope (%)	N/A	N/A	Clear Space to XWalk (in)	N/A
N/A	Any Obstructions?	N/A	N/A	Storm Grate/Utility Hazard?	N/A
	Obstruction Type			Storm Grate/Utility Type	
		N/A			N/A
			Yes	Surface Condition? (G/P)	Good

Possible Solutions:

Remove & Replace Entire Ramp.
