Intersection ID: 9256	Main Street: BOONE_ST	Cross Street: RENNER_ST	Location:	SE
ADA ID: 7E2832A4A62A	Ramp Type: Perp	Initial Pass/Fail: Fail	Overall Compliance: No	Severity Score: 1.25

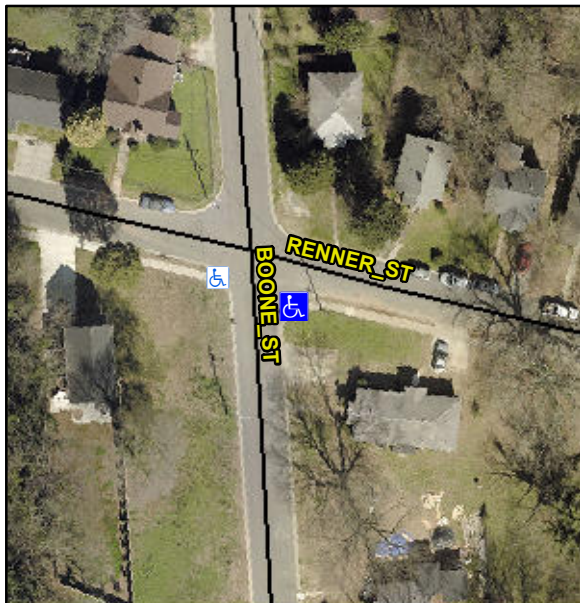
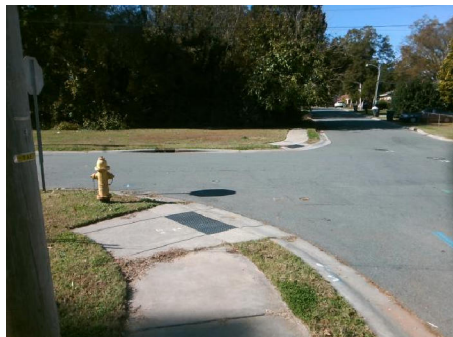
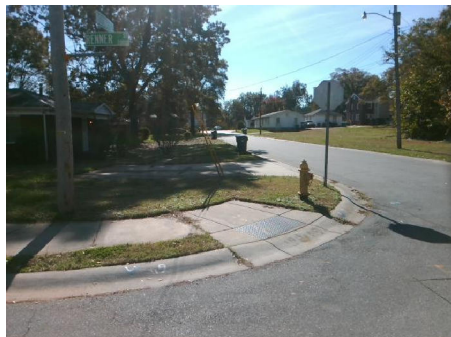
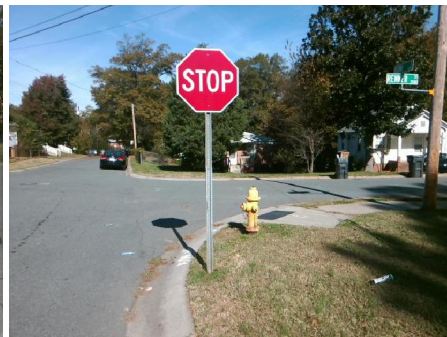
Possible Solutions:		Compliance	Description	Data	Compliance	Description	Data
	Remove & Replace Entire Ramp.		N/A	Ramp Length (in)	27.0	Yes	Ramp Slope (%)	5.9
			Yes	Ramp Width (in)	48.0	No	Ramp XSlope (%)	2.5
			N/A	Flare Type LT	N/A	N/A	Flare Type RT	N/A
			N/A	Flare Slope LT (%)	N/A	N/A	Flare Slope RT (%)	N/A
			N/A	Flare Traversable LT?	N/A	N/A	Flare Traversable RT?	N/A
			N/A	Landing Length (in)	N/A	N/A	DWS Provided?	N/A
			N/A	Landing Width (in)	N/A	N/A	DWS Contrast?	N/A
			N/A	Landing Slope (%)	N/A	N/A	DWS Length (in)	N/A
			N/A	Landing X Slope (%)	N/A	N/A	DWS Full Width?	N/A
Surveyor Notes:		N/A	N/A	Landing Curb? (Y/N)	N/A	N/A	DWS Offset (in)	N/A
PROW/ADA:		Not Found, R304.5.3	N/A	Shared Landing?	N/A			
			N/A	Gutter Ponding?	N/A	N/A	Gutter Slope (%)	N/A
			N/A	Gutter Lip Ht (in)	N/A	N/A	Gutter X Slope (%)	N/A

N/A	Painted X Walk1?	No	N/A	Painted X Walk2?	N/A
				X Walk 1 Direction	To NW		X Walk 2 Direction	N/A
			N/A	X Walk 1 Width (in)	N/A	N/A	X Walk 2 Width (in)	N/A
				X Walk 1 Slope (%)	3.9		X Walk 2 Slope (%)	N/A
				X Walk 1 X Slope (%)	2.7		X Walk 2 X Slope (%)	N/A
Street 1 Name		BOONE ST	N/A	Ramp inside XWalk1?	N/A	N/A	Ramp inside XWalk2?	N/A
Stop Condition-Street 2		StopSign		Road Slope (%)	N/A	N/A	Clear Space?	N/A
Street 2 Name		N/A		Road X Slope (%)	N/A	N/A	Clear Space to XWalk (in)	N/A
Stop Condition-Street 1		N/A		N/A	N/A	N/A	Storm Grate/Utility Hazard?	N/A
				Obstruction Type			Storm Grate/Utility Type	
Total Cost:		\$ 1850.00			N/A			N/A
						Yes	Surface Condition? (G/P)	Good
