Access Compliance Report Public Rights-of-Way (Curb Ramps)

Intersection ID: 12618	Main Street: E_5TH_ST	Cross Street: N_CALDWELL_ST	Location: NW
ADA ID: 7E3E27821485	Ramp Type: Perp	Initial Pass/Fail: Pass	Overall Compliance: No Severity Score: 0

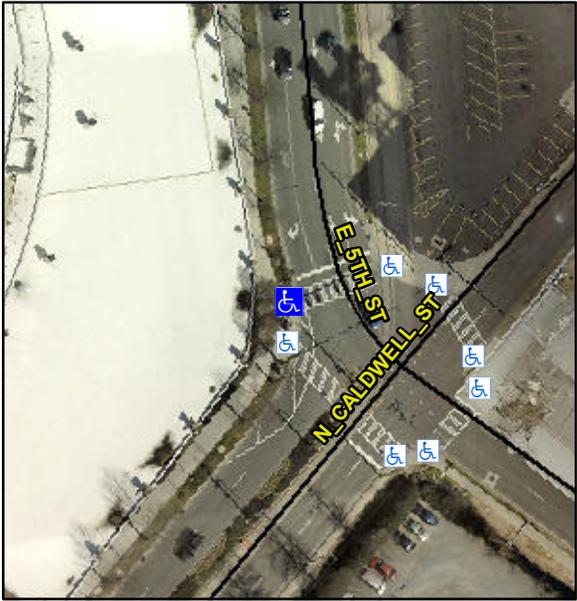
PROW/ADA:
Not Found, R304.2.1, R304.5.3

Compliance	Description	Data	Compliance	Description	Data
N/A	Ramp Length (in)	52.0	Yes	Ramp Slope (%)	6.5
Yes	Ramp Width (in)	48.0	Yes	Ramp XSlope (%)	1.0
N/A	Flare Type LT	Sloped	N/A	Flare Type RT	N/A
N/A	Flare Slope LT (%)	4.7	N/A	Flare Slope RT (%)	8.9
N/A	Flare Traversable LT?	Yes	N/A	Flare Traversable RT?	No
No	Landing Length (in)	45.0	Yes	DWS Provided?	Yes
Yes	Landing Width (in)	48.0	Yes	DWS Contrast?	Yes
Yes	Landing Slope (%)	1.4	Yes	DWS Length (in)	24.0
No	Landing X Slope (%)	2.4	Yes	DWS Full Width?	Yes
N/A	Landing Curb? (Y/N)	No	Yes	DWS Offset (in)	1.0
N/A	Shared Landing?	No			
Yes	Gutter Ponding?	No	Yes	Gutter Slope (%)	1.7
Yes	Gutter Lip Ht (in)	0.0	No	Gutter X Slope (%)	3.4
N/A	Painted X Walk1?	Yes	N/A	Painted X Walk2?	N/A
	X Walk 1 Direction	To E		X Walk 2 Direction	N/A
N/A	X Walk 1 Width (in)	116.0	N/A	X Walk 2 Width (in)	N/A
	X Walk 1 Slope (%)	1.7		X Walk 2 Slope (%)	N/A
	X Walk 1 X Slope (%)	2.3		X Walk 2 X Slope (%)	N/A

Yes	Ramp inside XWalk1?	Yes	N/A	Ramp inside XWalk2?	N/A
	Road Slope (%)	N/A	N/A	Clear Space?	Yes
	Road X Slope (%)	N/A	N/A	Clear Space to XWalk (in)	N/A
Yes	Any Obstructions?	No	Yes	Storm Grate/Utility Hazard?	No
	Obstruction Type			Storm Grate/Utility Type	
		N/A			N/A
			Yes	Surface Condition? (G/P)	Good

Possible Solutions:
**Remove & Replace Entire Ramp.
 Remove & Replace Gutter.**
