Access Compliance Report

Public Rights-of-Way

(Curb Ramps)

Intersection ID: 47817	Main Street: DUSKY_PINE_DR	Cross Street: ROCKMOOR_RIDGE_RD	Location: SE
ADA ID: 7E467E005C3A	Ramp Type: Perp	Initial Pass/Fail: Pass	Overall Compliance: No
			Severity Score: 12.75

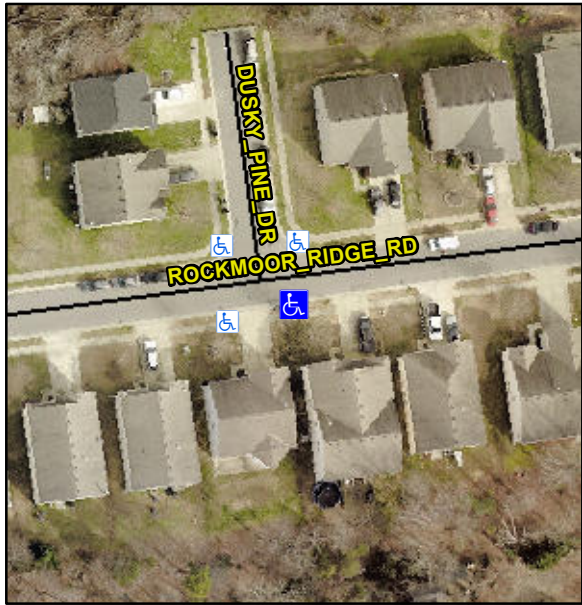
Possible Solutions:		Compliance			Description			Data	
	Remove & Replace Entire Ramp.		N/A	Ramp Length (in)	48.0	Yes	Ramp Slope (%)	5.2		
	Remove & Replace Gutter.		Yes	Ramp Width (in)	48.0	No	Ramp XSlope (%)	2.7		
			N/A	Flare Type LT	Sloped	N/A	Flare Type RT	N/A		
			N/A	Flare Slope LT (%)	4.6	N/A	Flare Slope RT (%)	0.5		
			N/A	Flare Traversable LT?	No	N/A	Flare Traversable RT?	No		
			Yes	Landing Length (in)	48.0	Yes	DWS Provided?	Yes		
			Yes	Landing Width (in)	48.0	Yes	DWS Contrast?	Yes		
			Yes	Landing Slope (%)	1.9	Yes	DWS Length (in)	24.5		
			No	Landing X Slope (%)	3.0	Yes	DWS Full Width?	Yes		
Surveyor Notes:		N/A			Yes			DWS Offset (in)	0.0	
PROW/ADA:		Not Found, R304.5.3, R302.7, R302.7.2, R304.5.4			No			Shared Landing?	No	
					No			Gutter Ponding?	Yes	
					No			Gutter Lip Ht (in)	0.5	
					N/A			Painted X Walk1?	No

To N			X Walk 1 Direction	N/A	
					N/A			X Walk 1 Width (in)	N/A	
					1.3			X Walk 1 Slope (%)	N/A	
					2.1			X Walk 1 X Slope (%)	N/A	
					N/A			Ramp inside XWalk1?	N/A	
					N/A			Road Slope (%)	N/A	
					N/A			Road X Slope (%)	N/A	
		Yes			No			Any Obstructions?	Yes	
								Obstruction Type	N/A	
									N/A	
					Yes			Surface Condition? (G/P)	Good
