# Access Compliance Report

## Public Rights-of-Way

### (Curb Ramps)

Intersection ID: 51243	Main Street: NORTHCREST SHOPPING CENTER DR	Access Street: W W T HARRIS BV	Location: NW
ADA ID: 7E498B1C1BE6	Ramp Type: Perp	Initial Pass/Fail: Fail	Overall Compliance: No
		Severity Score: 12.5

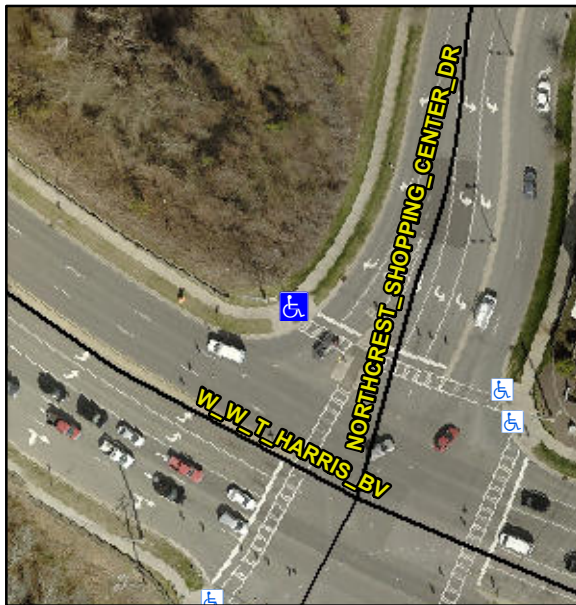
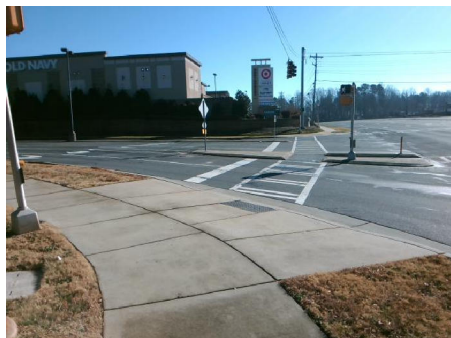
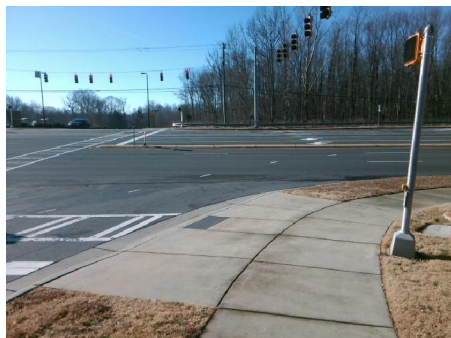
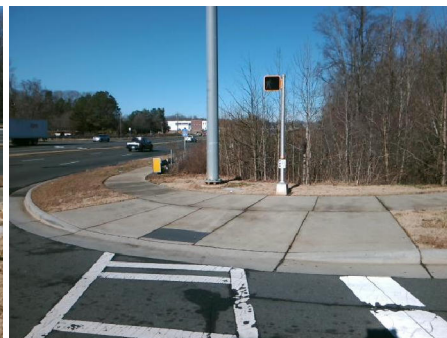
**Not Found, R304.5.3**

Compliance	Description	Data	Compliance	Description	Data
N/A	Ramp Length (in)	96.0	Yes	Ramp Slope (%)	6.8
Yes	Ramp Width (in)	48.0	No	Ramp XSlope (%)	5.1
N/A	Flare Type LT	N/A	N/A	Flare Type RT	N/A
N/A	Flare Slope LT (%)	N/A	N/A	Flare Slope RT (%)	N/A
N/A	Flare Traversable LT?	N/A	N/A	Flare Traversable RT?	N/A
N/A	Landing Length (in)	N/A	N/A	DWS Provided?	N/A
N/A	Landing Width (in)	N/A	N/A	DWS Contrast?	N/A
N/A	Landing Slope (%)	N/A	N/A	DWS Length (in)	N/A
N/A	Landing X Slope (%)	N/A	N/A	DWS Full Width?	N/A
N/A	Landing Curb? (Y/N)	N/A	N/A	DWS Offset (in)	N/A
N/A	Shared Landing?	N/A			
N/A	Gutter Ponding?	N/A	N/A	Gutter Slope (%)	N/A
N/A	Gutter Lip Ht (in)	N/A	N/A	Gutter X Slope (%)	N/A
N/A	Painted X Walk1?	Yes	N/A	Painted X Walk2?	N/A
	X Walk 1 Direction	To SE		X Walk 2 Direction	N/A
N/A	X Walk 1 Width (in)	78.0	N/A	X Walk 2 Width (in)	N/A
	X Walk 1 Slope (%)	2.2		X Walk 2 Slope (%)	N/A
	X Walk 1 X Slope (%)	3.3		X Walk 2 X Slope (%)	N/A

N/A	Ramp inside XWalk1?	Yes	N/A	Ramp inside XWalk2?	N/A
	Road Slope (%)	N/A	N/A	Clear Space?	N/A
	Road X Slope (%)	N/A	N/A	Clear Space to XWalk (in)	N/A
N/A	Any Obstructions?	N/A	N/A	Storm Grate/Utility Hazard?	N/A
	Obstruction Type			Storm Grate/Utility Type	
		N/A			N/A
		Yes		Surface Condition? (G/P)	Good

**Remove & Replace Entire Ramp.**

Total Cost: \$ 1850.00
