# Access Compliance Report

## Public Rights-of-Way

### (Curb Ramps)

Intersection ID: 10865	Main Street: SUMTER_AV	Cross Street: AUTEN_ST	Location: S
ADA ID: 7E59E4A34DD2	Ramp Type: Perp	Initial Pass/Fail: Fail	Overall Compliance: No
		Severity Score: 55

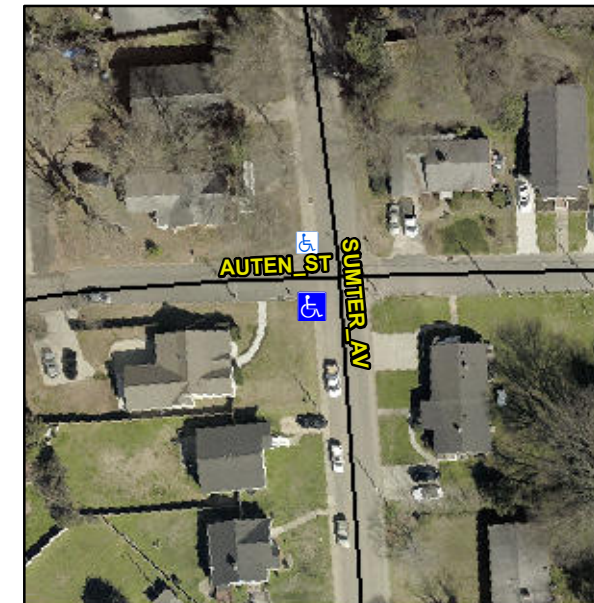
**Not Found, R304.5.1, R304.2.2, R304.5.3**

Compliance	Description	Data	Compliance	Description	Data
N/A	Ramp Length (in)	46.0	No	Ramp Slope (%)	9.4
No	Ramp Width (in)	34.0	No	Ramp XSlope (%)	13.4
N/A	Flare Type LT	N/A	N/A	Flare Type RT	N/A
N/A	Flare Slope LT (%)	N/A	N/A	Flare Slope RT (%)	N/A
N/A	Flare Traversable LT?	N/A	N/A	Flare Traversable RT?	N/A
N/A	Landing Length (in)	N/A	N/A	DWS Provided?	N/A
N/A	Landing Width (in)	N/A	N/A	DWS Contrast?	N/A
N/A	Landing Slope (%)	N/A	N/A	DWS Length (in)	N/A
N/A	Landing X Slope (%)	N/A	N/A	DWS Full Width?	N/A
N/A	Landing Curb? (Y/N)	N/A	N/A	DWS Offset (in)	N/A
N/A	Shared Landing?	N/A			
N/A	Gutter Ponding?	N/A	N/A	Gutter Slope (%)	N/A
N/A	Gutter Lip Ht (in)	N/A	N/A	Gutter X Slope (%)	N/A
N/A	Painted X Walk1?	No	N/A	Painted X Walk2?	N/A
	X Walk 1 Direction	To N		X Walk 2 Direction	N/A
N/A	X Walk 1 Width (in)	N/A	N/A	X Walk 2 Width (in)	N/A
	X Walk 1 Slope (%)	12.7		X Walk 2 Slope (%)	N/A
	X Walk 1 X Slope (%)	2.3		X Walk 2 X Slope (%)	N/A

N/A	Ramp inside XWalk1?	N/A	N/A	Ramp inside XWalk2?	N/A
	Road Slope (%)	N/A	N/A	Clear Space?	N/A
	Road X Slope (%)	N/A	N/A	Clear Space to XWalk (in)	N/A
N/A	Any Obstructions?	N/A	N/A	Storm Grate/Utility Hazard?	N/A
	Obstruction Type			Storm Grate/Utility Type	
		N/A			N/A
			Yes	Surface Condition? (G/P)	Good

**Remove & Replace Entire Ramp.**
