Access Compliance Report

Public Rights-of-Way

(Curb Ramps)

Intersection ID: N/A	Main Street: KIRKWYND COMMONS DR	Cross Street: TRAILMOOR RD	Location: NE
ADA ID: 7E5EE4B8BA21	Ramp Type: Perp	Initial Pass/Fail: Fail	Overall Compliance: No
Severity Score: 12.5			
Codes/Mitigation Info/Possible Solution		Field Measurements/Component Compliance

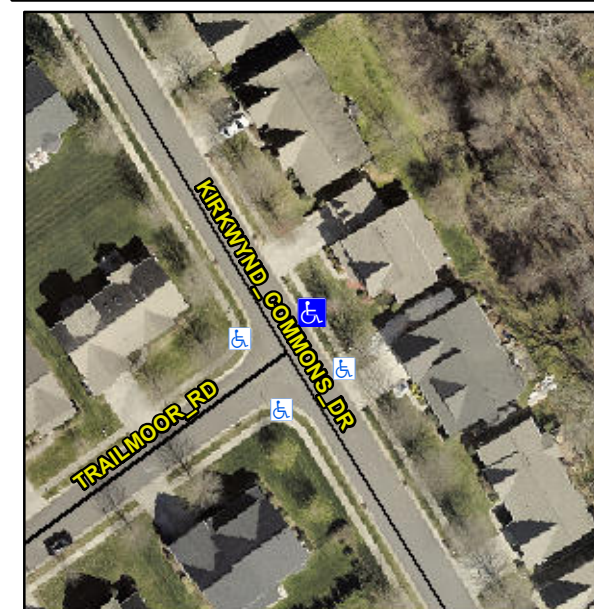
Compliance	Description	Data	Compliance	Description	Data
N/A	Ramp Length (in)	48.0	No	Ramp Slope (%)	9.5
Yes	Ramp Width (in)	48.0	Yes	Ramp XSlope (%)	0.8
N/A	Flare Type LT	N/A	N/A	Flare Type RT	N/A
N/A	Flare Slope LT (%)	N/A	N/A	Flare Slope RT (%)	N/A
N/A	Flare Traversable LT?	N/A	N/A	Flare Traversable RT?	N/A
N/A	Landing Length (in)	N/A	N/A	DWS Provided?	N/A
N/A	Landing Width (in)	N/A	N/A	DWS Contrast?	N/A
N/A	Landing Slope (%)	N/A	N/A	DWS Length (in)	N/A
N/A	Landing X Slope (%)	N/A	N/A	DWS Full Width?	N/A
N/A	Landing Curb? (Y/N)	N/A	N/A	DWS Offset (in)	N/A
N/A	Shared Landing?	N/A			
N/A	Gutter Ponding?	N/A	N/A	Gutter Slope (%)	N/A
N/A	Gutter Lip Ht (in)	N/A	N/A	Gutter X Slope (%)	N/A
N/A	Painted X Walk1?	No	N/A	Painted X Walk2?	N/A
	X Walk 1 Direction	To SW		X Walk 2 Direction	N/A
N/A	X Walk 1 Width (in)	N/A	N/A	X Walk 2 Width (in)	N/A
	X Walk 1 Slope (%)	3.9		X Walk 2 Slope (%)	N/A
	X Walk 1 X Slope (%)	3.3		X Walk 2 X Slope (%)	N/A

Possible Solutions:

Remove & Replace Entire Ramp.

R304.2.2

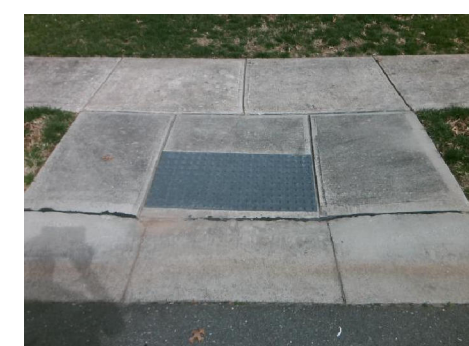
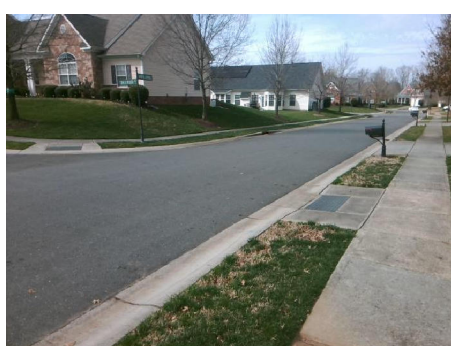
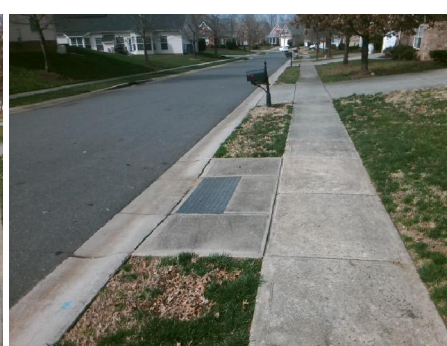
N/A	Ramp inside XWalk1?	N/A	N/A	Ramp inside XWalk2?	N/A
	Road Slope (%)	N/A	N/A	Clear Space?	N/A
	Road X Slope (%)	N/A	N/A	Clear Space to XWalk (in)	N/A
N/A	Any Obstructions?	N/A	N/A	Storm Grate/Utility Hazard?	N/A
	Obstruction Type			Storm Grate/Utility Type	
		N/A			N/A
			Yes	Surface Condition? (G/P)	Good
