# Access Compliance Report

## Public Rights-of-Way

### (Curb Ramps)

Intersection ID: 48998	Main Street: FALLON_FARM_RD	Cross Street: STEELECROFT_PY	Location: NW
ADA ID: 7E6A0A95692A	Ramp Type: BlendTrans1	Initial Pass/Fail: Fail	Overall Compliance: No
Severity Score: 1.25			
Codes/Mitigation Info/Possible Solution		Field Measurements/Component Compliance

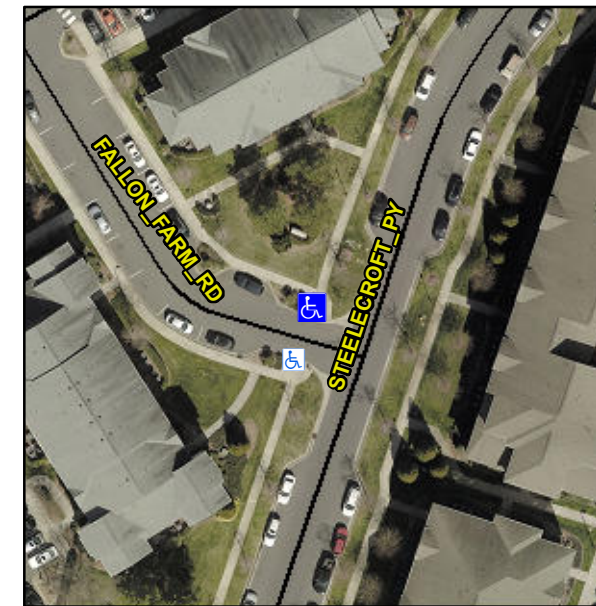
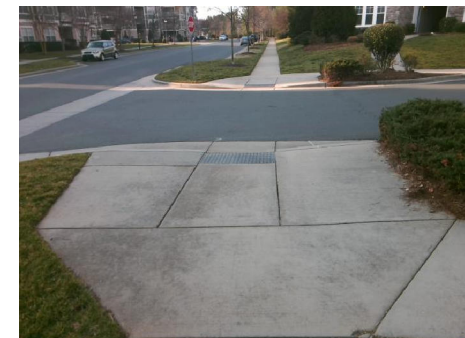
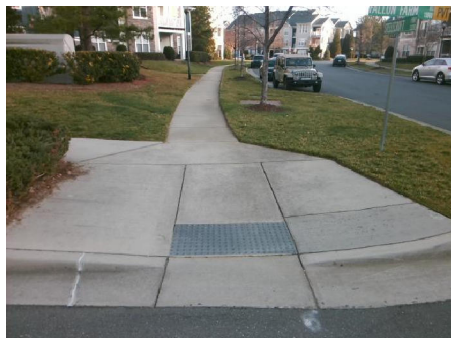
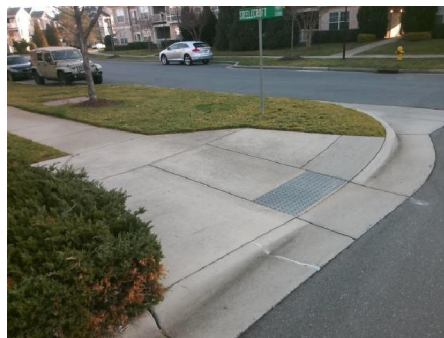
Compliance	Description	Data	Compliance	Description	Data
N/A	Ramp Length (in)	107.0	Yes	BlendTrans Slope (%)	2.7
Yes	Ramp Width (in)	48.5	No	BlendTrans XSlope (%)	2.1
N/A	Flare Type LT	N/A	N/A	Flare Type RT	N/A
N/A	Flare Slope LT (%)	N/A	N/A	Flare Slope RT (%)	N/A
N/A	Flare Traversable LT?	N/A	N/A	Flare Traversable RT?	N/A
N/A	Landing Length (in)	N/A	N/A	DWS Provided?	N/A
N/A	Landing Width (in)	N/A	N/A	DWS Contrast?	N/A
N/A	Landing Slope (%)	N/A	N/A	DWS Length (in)	N/A
N/A	Landing X Slope (%)	N/A	N/A	DWS Full Width?	N/A
N/A	Landing Curb? (Y/N)	N/A	N/A	DWS Offset (in)	N/A
N/A	Shared Landing?	N/A			
N/A	Gutter Ponding?	N/A	N/A	Gutter Slope (%)	N/A
N/A	Gutter Lip Ht (in)	N/A	N/A	Gutter X Slope (%)	N/A
N/A	Painted X Walk1?	No	N/A	Painted X Walk2?	N/A
	X Walk 1 Direction	To SW		X Walk 2 Direction	N/A
	X Walk 1 Width (in)	N/A		X Walk 2 Width (in)	N/A
	X Walk 1 Slope (%)	0.6		X Walk 2 Slope (%)	N/A
	X Walk 1 X Slope (%)	1.8		X Walk 2 X Slope (%)	N/A

N/A	Ramp inside XWalk1?	N/A	N/A	Ramp inside XWalk2?	N/A
	Road Slope (%)	1.8		Clear Space?	N/A
	Road X Slope (%)	0.6	N/A	Clear Space to XWalk (in)	N/A
N/A	Any Obstructions?	N/A	N/A	Storm Grate/Utility Hazard?	N/A
	Obstruction Type			Storm Grate/Utility Type	
		N/A			N/A
			Yes	Surface Condition? (G/P)	Good
			N/A	Curb Slope (%)	0.4

**Remove & Replace Curb Ramp With Two New Directional Ramps or Equivalent.**

**R304.5.3**
