# Access Compliance Report

## Public Rights-of-Way

### (Curb Ramps)

Intersection ID: 10789	Main Street: MAHOPAC_ST	Cross Street: S_BRUNS_AV	Location: S
ADA ID: 7E6D5E85442B	Ramp Type: Perp	Initial Pass/Fail: Fail	Overall Compliance: No
		Severity Score: 37.5

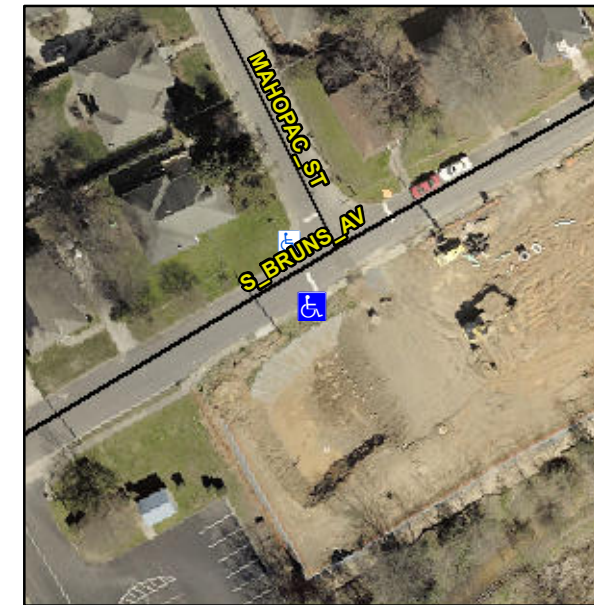
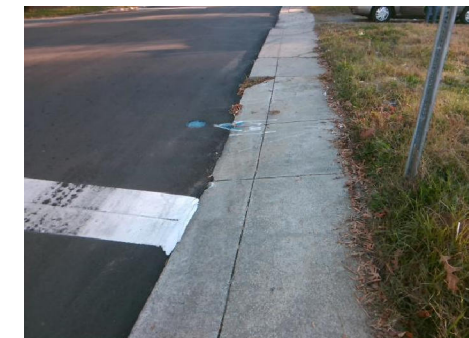
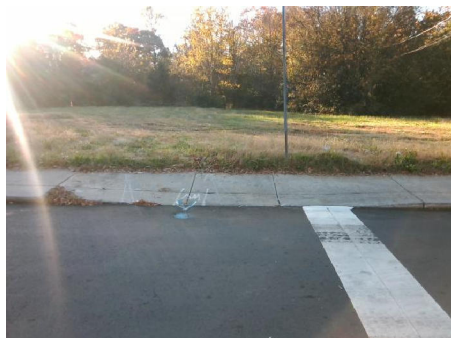
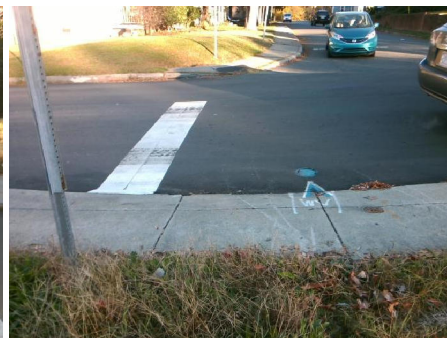
**Not Found, R304.2.2, R304.5.3**

Compliance	Description	Data	Compliance	Description	Data
N/A	Ramp Length (in)	37.0	No	Ramp Slope (%)	11.8
Yes	Ramp Width (in)	48.0	No	Ramp XSlope (%)	7.7
N/A	Flare Type LT	N/A	N/A	Flare Type RT	N/A
N/A	Flare Slope LT (%)	N/A	N/A	Flare Slope RT (%)	N/A
N/A	Flare Traversable LT?	N/A	N/A	Flare Traversable RT?	N/A
N/A	Landing Length (in)	N/A	N/A	DWS Provided?	N/A
N/A	Landing Width (in)	N/A	N/A	DWS Contrast?	N/A
N/A	Landing Slope (%)	N/A	N/A	DWS Length (in)	N/A
N/A	Landing X Slope (%)	N/A	N/A	DWS Full Width?	N/A
N/A	Landing Curb? (Y/N)	N/A	N/A	DWS Offset (in)	N/A
N/A	Shared Landing?	N/A			
N/A	Gutter Ponding?	N/A	N/A	Gutter Slope (%)	N/A
N/A	Gutter Lip Ht (in)	N/A	N/A	Gutter X Slope (%)	N/A
N/A	Painted X Walk1?	No	N/A	Painted X Walk2?	N/A
	X Walk 1 Direction	To N		X Walk 2 Direction	N/A
N/A	X Walk 1 Width (in)	N/A	N/A	X Walk 2 Width (in)	N/A
	X Walk 1 Slope (%)	5.4		X Walk 2 Slope (%)	N/A
	X Walk 1 X Slope (%)	5.6		X Walk 2 X Slope (%)	N/A

N/A	Ramp inside XWalk1?	N/A	N/A	Ramp inside XWalk2?	N/A
	Road Slope (%)	N/A	N/A	Clear Space?	N/A
	Road X Slope (%)	N/A	N/A	Clear Space to XWalk (in)	N/A
N/A	Any Obstructions?	N/A	N/A	Storm Grate/Utility Hazard?	N/A
	Obstruction Type			Storm Grate/Utility Type	
		N/A			N/A
			Yes	Surface Condition? (G/P)	Good

**Remove & Replace Entire Ramp.**

**\$ 1850.00**
