Access Compliance Report

Public Rights-of-Way

(Curb Ramps)

| Intersection ID: 5714 | Main Street: JOHN_KIRK_DR | Cross Street: UNIVERSITY_CITY_BV | Location: E |

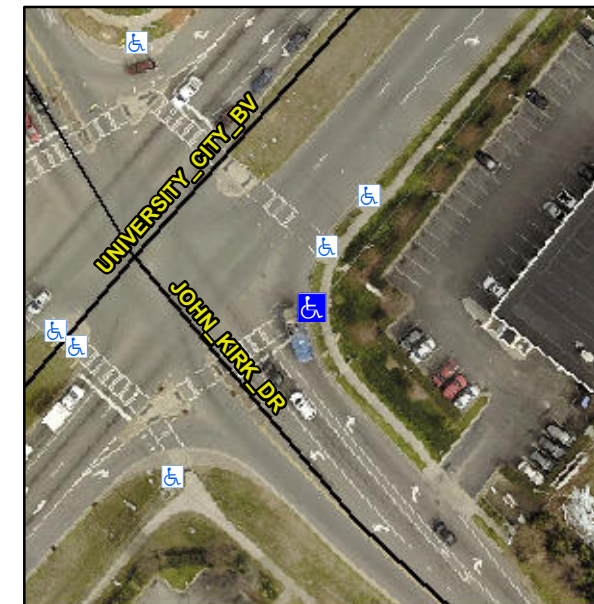
| ADA ID: 7E7D26FDF17F | Ramp Type: Perp | Initial Pass/Fail: Fail | Overall Compliance: No |
| Severity Score: 22.5 | | | |

Not Found, R304.5.1, R304.2.2

| Compliance | Description | Data | Compliance | Description | Data |
|---|---|---|---|---|---|
| N/A | Ramp Length (in) | 59.0 | No | Ramp Slope (%) | 10.1 |
| No | Ramp Width (in) | 47.1 | Yes | Ramp XSlope (%) | 2.8 |

Possible Solutions:

Remove & Replace Entire Ramp.
