## Access Compliance Report Public Rights-of-Way (Curb Ramps)

Intersection ID: 15217Main Street: ALBEMARLE\_RDCross Street: WINTERHAVEN\_DRLocation:NWADA ID: 7E8FED18AD12Ramp Type: PerpInitial Pass/Fail: FailOverall Compliance: NoSeverity Score: 22.5

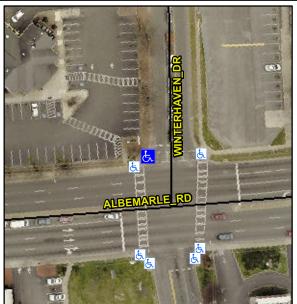
Field Measurements/Component Compliance									
Comp	liance Description	Data	Comp	liance	Description	Data			
N/A	Ramp Length (in)	60.0	No	Ramp	Slope (%)	10.0			
No	Ramp Width (in)	43.0	No	Ramp	XSlope (%)	4.7			
N/A	Flare Type LT	N/A	N/A	Flare	Type RT	N/A			
N/A	Flare Slope LT (%)	N/A	N/A	Flare	Slope RT (%)	N/A			
N/A	Flare Traversable LT?	N/A	N/A	Flare	Traversable RT?	N/A			
N/A	Landing Length (in)	N/A	N/A	DWS	Provided?	N/A			
N/A	Landing Width (in)	N/A	N/A	DWS	Contrast?	N/A			
N/A	Landing Slope (%)	N/A	N/A	DWS	Length (in)	N/A			
N/A	Landing X Slope (%)	N/A	N/A	DWS	Full Width?	N/A			
N/A	Landing Curb? (Y/N)	N/A	N/A	DWS	Offset (in)	N/A			
N/A	Shared Landing?	N/A							
N/A	Gutter Ponding?	N/A	N/A	Gutte	r Slope (%)	N/A			
N/A	Gutter Lip Ht (in)	N/A	N/A	Gutte	r X Slope (%)	N/A			
N/A	Painted X Walk1?	Yes	N/A	Paint	ed X Walk2?	N/A			
	X Walk 1 Direction	То Е		X Wa	lk 2 Direction	N/A			
N/A	X Walk 1 Width (in)	114.0	N/A	X Wa	lk 2 Width (in)	N/A

X Walk 1 Slope (%)	3.7		X Wa	lk 2 Slope (%)	N/A			
	X Walk 1 X Slope (%)	3.4		X Wa	lk 2 X Slope (%)	N/A			
N/A	Ramp inside XWalk1?	Yes	N/A	Ramp	inside XWalk2?	N/A			
	Road Slope (%)	N/A	N/A	Clear	Space?	N/A			
	Road X Slope (%)	N/A	N/A	Clear	Space to XWalk (in)	N/A			
N/A	Any Obstructions?	N/A	N/A	Storm	Grate/Utility Hazard?	N/A			
	Obstruction Type			Storm	Grate/Utility Type				
		N/A				N/A			
			Yes	Surfa	ce Condition? (G/P)	Good

Possible Solutions:
Remove & Replace Entire Ramp.
Surveyor Notes:
N/A
PROW/ADA:
Not Found, R304.5.1, R304.2.2,
R304.5.3
