## **Access Compliance Report Public Rights-of-Way** (Curb Ramps)

Intersection ID: 25141 Main Street: PINEVILLE-MATTHEWS RD Cross Street: RIDGELOCH PL Location: NE ADA ID: 7E93873FDF7D

Ramp Type: PerpDiag Initial Pass/Fail: Fail **Overall Compliance: No** Severity Score: 13.75

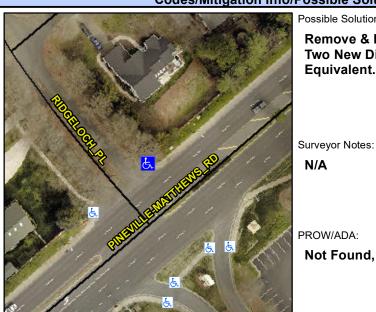
Not Found, R304.2.2, R304.5.3

Comp	oliance Description	Data	Comp	oliance Description	Data
N/A	Ramp Length (in)	60.0	No	Ramp Slope (%)	8.8
Yes	Ramp Width (in)	48.0	No	Ramp XSlope (%)	2.9
N/A	Flare Type LT	N/A	N/A	Flare Type RT	N/A
N/A	Flare Slope LT (%)	N/A	N/A	Flare Slope RT (%)	N/A
N/A	Flare Traversable LT?	N/A	N/A	Flare Traversable RT?	N/A
N/A	Landing Length (in)	N/A	N/A	DWS Provided?	N/A
N/A	Landing Width (in)	N/A	N/A	DWS Contrast?	N/A
N/A	Landing Slope (%)	N/A	N/A	DWS Length (in)	N/A
N/A	Landing X Slope (%)	N/A	N/A	DWS Full Width?	N/A
N/A	Landing Curb? (Y/N)	N/A	N/A	DWS Offset (in)	N/A
N/A	Shared Landing?	N/A			
N/A	Gutter Ponding?	N/A	N/A	Gutter Slope (%)	N/A
N/A	Gutter Lip Ht (in)	N/A	N/A	Gutter X Slope (%)	N/A
N/A	Painted X Walk1?	No	N/A	Painted X Walk2?	No
	X Walk 1 Direction	To SW		X Walk 2 Direction	To SE
N/A	X Walk 1 Width (in)	N/A	N/A	X Walk 2 Width (in)	N/A
	X Walk 1 Slope (%)	4.8		X Walk 2 Slope (%)	1.2
	X Walk 1 X Slope (%)	1.1		X Walk 2 X Slope (%)	3.5

N/A	Ramp inside XWalk1?	N/A	N/A	Ramp inside XWalk2?	N/A
	Road Slope (%)	2.0	N/A	Clear Space?	N/A
	Road X Slope (%)	4.6	N/A	Clear Space to XWalk (in)	N/A
N/A	Any Obstructions?	N/A	N/A	Storm Grate/Utility Hazard?	N/A
	Obstruction Type			Storm Grate/Utility Type

Possible Solutions: Remove & Replace Curb Ramp With **Two New Directional Ramps or** Equivalent.
