# Access Compliance Report

## Public Rights-of-Way

### (Curb Ramps)

| Intersection ID: 3125 | Main Street: JOHNSTON_OEHLER_RD | Cross Street: MOURNING_DOVE_LN | Location: SE |

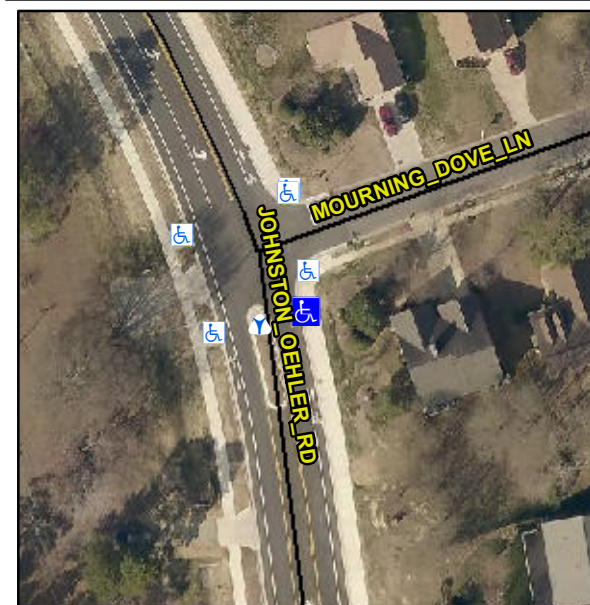
**RT RP < 5%**

**R304.5.3, R304.2.2-Perp, R304.3.2-Para, R304.2.3**

| Compliance | Description | Data | Compliance | Description | Data |
|---|---|---|---|---|---|
| No | Ramp XSlope LT (%) | 3.5 | Yes | Ramp XSlope RT (%) | 1.6 |
| Yes | Ramp Width (in) | 48.0 | No | Ramp XSlope (%) | 2.6 |
| No | Flare Slope LT (%) | 12.6 | Yes | Flare Slope RT (%) | 7.1 |
| No | Landing Slope (%) | 2.2 | Yes | DWS Length (in) | 24.0 |

**Remove & Replace Entire Ramp.**

Total Cost: \$ 1800.00
