Access Compliance Report

Public Rights-of-Way

(Curb Ramps)

Intersection ID: 49003	Main Street: STEELE_CREEK_RD	Cross Street: STEELECROFT_PY	Location: SW
ADA ID: 7EAD9E2E64C1	Ramp Type: Perp	Initial Pass/Fail: Fail	Overall Compliance: No
		Severity Score: 10

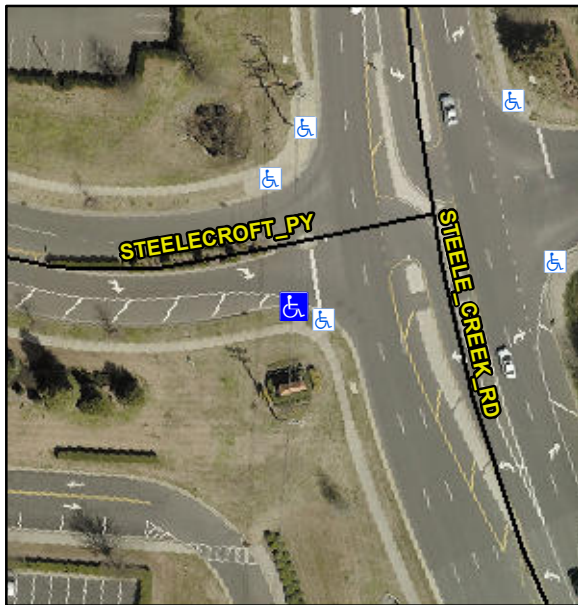
Not Found, R304.5.1, R304.5.3

Compliance	Description	Data	Compliance	Description	Data
N/A	Ramp Length (in)	95.5	Yes	Ramp Slope (%)	5.5
No	Ramp Width (in)	46.5	No	Ramp XSlope (%)	2.4
N/A	Flare Type LT	N/A	N/A	Flare Type RT	N/A
N/A	Flare Slope LT (%)	N/A	N/A	Flare Slope RT (%)	N/A
N/A	Flare Traversable LT?	N/A	N/A	Flare Traversable RT?	N/A
N/A	Landing Length (in)	N/A	N/A	DWS Provided?	N/A
N/A	Landing Width (in)	N/A	N/A	DWS Contrast?	N/A
N/A	Landing Slope (%)	N/A	N/A	DWS Length (in)	N/A
N/A	Landing X Slope (%)	N/A	N/A	DWS Full Width?	N/A
N/A	Landing Curb? (Y/N)	N/A	N/A	DWS Offset (in)	N/A
N/A	Shared Landing?	N/A			
N/A	Gutter Ponding?	N/A	N/A	Gutter Slope (%)	N/A
N/A	Gutter Lip Ht (in)	N/A	N/A	Gutter X Slope (%)	N/A
N/A	Painted X Walk1?	No	N/A	Painted X Walk2?	N/A
	X Walk 1 Direction	To N		X Walk 2 Direction	N/A
N/A	X Walk 1 Width (in)	N/A	N/A	X Walk 2 Width (in)	N/A
	X Walk 1 Slope (%)	2.9		X Walk 2 Slope (%)	N/A
	X Walk 1 X Slope (%)	1.5		X Walk 2 X Slope (%)	N/A

N/A	Ramp inside XWalk1?	N/A	N/A	Ramp inside XWalk2?	N/A
	Road Slope (%)	N/A	N/A	Clear Space?	N/A
	Road X Slope (%)	N/A	N/A	Clear Space to XWalk (in)	N/A
N/A	Any Obstructions?	N/A	N/A	Storm Grate/Utility Hazard?	N/A
	Obstruction Type			Storm Grate/Utility Type	
		N/A			N/A
			Yes	Surface Condition? (G/P)	Good

Remove & Replace Entire Ramp.
