# Access Compliance Report

## Public Rights-of-Way

### (Curb Ramps)

Intersection ID: 15139	Main Street: EAST_BV	Cross Street: KENILWORTH_AV	Location: E
ADA ID: 7EAFFAE162	Ramp Type: BlendTrans1	Initial Pass/Fail: Fail	Overall Compliance: No
Severity Score: 8.75			
Codes/Mitigation Info/Possible Solution		Field Measurements/Component Compliance

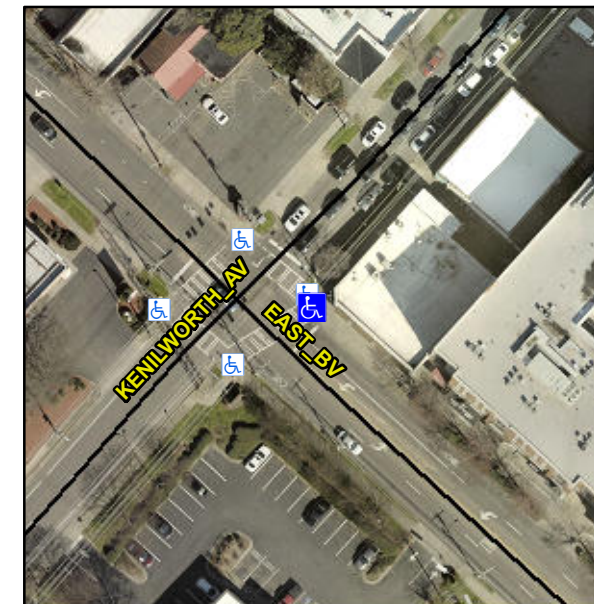
Compliance	Description	Data	Compliance	Description	Data
N/A	Ramp Length (in)	54.0	Yes	BlendTrans Slope (%)	2.2
No	Ramp Width (in)	47.0	Yes	BlendTrans XSlope (%)	0.1
N/A	Flare Type LT	N/A	N/A	Flare Type RT	N/A
N/A	Flare Slope LT (%)	N/A	N/A	Flare Slope RT (%)	N/A
N/A	Flare Traversable LT?	N/A	N/A	Flare Traversable RT?	N/A
N/A	Landing Length (in)	N/A	N/A	DWS Provided?	N/A
N/A	Landing Width (in)	N/A	N/A	DWS Contrast?	N/A
N/A	Landing Slope (%)	N/A	N/A	DWS Length (in)	N/A
N/A	Landing X Slope (%)	N/A	N/A	DWS Full Width?	N/A
N/A	Landing Curb? (Y/N)	N/A	N/A	DWS Offset (in)	N/A
N/A	Shared Landing?	N/A			
N/A	Gutter Ponding?	N/A	N/A	Gutter Slope (%)	N/A
N/A	Gutter Lip Ht (in)	N/A	N/A	Gutter X Slope (%)	N/A
N/A	Painted X Walk1?	Yes	N/A	Painted X Walk2?	N/A
	X Walk 1 Direction	To SW		X Walk 2 Direction	N/A
	X Walk 1 Width (in)	116.0		X Walk 2 Width (in)	N/A
	X Walk 1 Slope (%)	3.4		X Walk 2 Slope (%)	N/A
	X Walk 1 X Slope (%)	1.4		X Walk 2 X Slope (%)	N/A

N/A	Ramp inside XWalk1?	Yes	N/A	Ramp inside XWalk2?	N/A
	Road Slope (%)	1.4		Clear Space?	N/A
	Road X Slope (%)	3.4	N/A	Clear Space to XWalk (in)	N/A
N/A	Any Obstructions?	N/A	N/A	Storm Grate/Utility Hazard?	N/A
	Obstruction Type			Storm Grate/Utility Type	
		N/A			N/A
			Yes	Surface Condition? (G/P)	Good
			N/A	Curb Slope (%)	0.9

**Remove & Replace Curb Ramp With Two New Directional Ramps or Equivalent.**

**R304.5.1**
