Access Compliance Report

Public Rights-of-Way

(Curb Ramps)

Intersection ID: N/A	Main Street: LOG_CABIN_RD	Cross Street: SQUIRREL_HILL_RD	Location: SE
ADA ID: 7EC68F8A3F04	Ramp Type: Combination2Diag	Initial Pass/Fail: Fail	Overall Compliance: No
Severity Score: 0			
Codes/Mitigation Info/Possible Solution		Field Measurements/Component Compliance

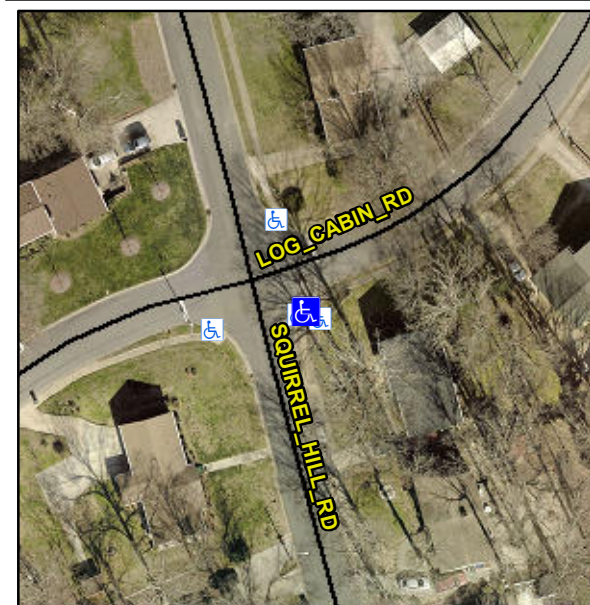
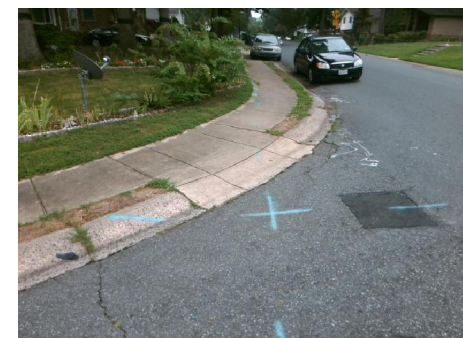
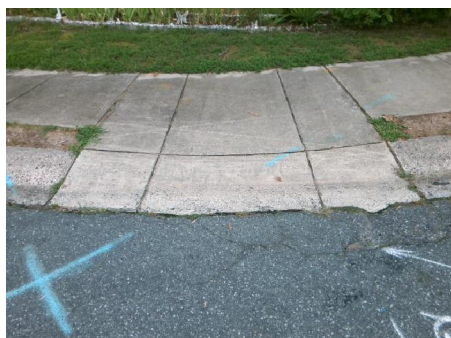
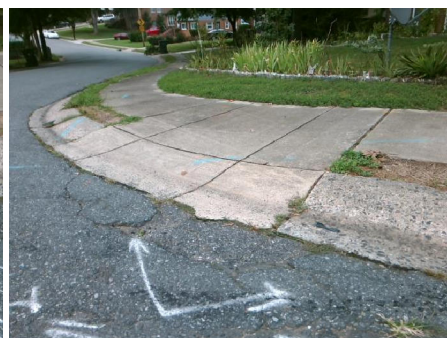
Not Found, R304.5.1, R304.5.1, R304.5.3, R304.3.2

Compliance	Description	Data	Compliance	Description	Data
N/A	Ramp Length LT (in)	21.5	N/A	Ramp Length RT (in)	20.5
No	Ramp Width LT (in)	47.0	No	Ramp Width RT (in)	47.5
Yes	Ramp Slope LT (%)	2.4	No	Ramp Slope RT (%)	10.8
No	Ramp XSlope LT (%)	3.8	No	Ramp XSlope RT (%)	3.8
N/A	Ramp Length (in)	12.0	Yes	Ramp Slope (%)	7.9
No	Ramp Width (in)	44.0	No	Ramp XSlope (%)	6.3
N/A	Flare Type LT	N/A	N/A	Flare Type RT	N/A
N/A	Flare Slope LT (%)	N/A	N/A	Flare Slope RT (%)	N/A
N/A	Flare Traversable LT?	N/A	N/A	Flare Traversable RT?	N/A
N/A	Landing Length (in)	N/A	N/A	DWS Provided?	N/A
N/A	Landing Width (in)	N/A	N/A	DWS Contrast?	N/A
N/A	Landing Slope (%)	N/A	N/A	DWS Length (in)	N/A
N/A	Landing X Slope (%)	N/A	N/A	DWS Full Width?	N/A
N/A	Landing Curb? (Y/N)	N/A	N/A	DWS Offset (in)	N/A
N/A	Shared Landing?	N/A			
N/A	Gutter Ponding?	N/A	N/A	Gutter Slope (%)	N/A
N/A	Gutter Lip Ht (in)	N/A	N/A	Gutter X Slope (%)	N/A
N/A	Painted X Walk1?	No	N/A	Painted X Walk2?	No

X Walk 1 Direction	To N		X Walk 2 Direction	To W
	X Walk 1 Width (in)	N/A		X Walk 2 Width (in)	N/A
	X Walk 1 Slope (%)	1.2		X Walk 2 Slope (%)	7.6
	X Walk 1 X Slope (%)	7.9		X Walk 2 X Slope (%)	0.2
N/A	Ramp inside XWalk1?	N/A	N/A	Ramp inside XWalk2?	N/A
	Road Slope (%)	5.4		Clear Space?	N/A
	Road X Slope (%)	5.6	N/A	Clear Space to XWalk (in)	N/A
			N/A	Any Obstruction?	N/A
				Obstruction Type	N/A
			N/A	Storm Grate/Utility Hazard?	N/A
				Storm Grate/Utility Type	N/A
Yes	Surface Condition? (G/P)	Good			
	Curb Slope (%)	25.6

Remove & Replace Curb Ramp With Two New Directional Ramps or Equivalent.
