## **Access Compliance Report Public Rights-of-Way** (Curb Ramps)

Intersection ID: 7945 Main Street: DAVID\_AV Cross Street: LITTLE\_ROCK\_RD Location: S **Overall Compliance: No**

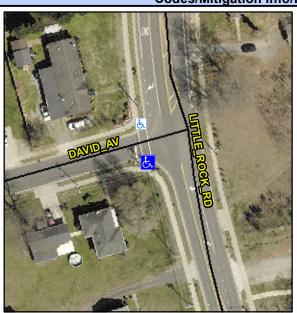
Initial Pass/Fail: Fail

Ramp Type: Perp

- Ossible Solution			r leid Measurements/Component Compilance						
Possible Solutions:			Compliance Description		Data	a Compliance Description			
Remove & Replace Entire	Ram	ıp.	N/A	Ramp Length (in)	96.0	Yes	Ramp Slope (%)

•		•	No	Ramp Width (in)	47.0	Yes	Ramp XSlope (%)		
			N/A	Flare Type LT	N/A	N/A	Flare Type RT		
			N/A	Flare Slope LT (%)	N/A	N/A	Flare Slope RT (%)		
			N/A	Flare Traversable LT?	N/A	N/A	Flare Traversable RT?		
		N/A	Landing Length (in)	N/A	N/A	DWS Provided?			
Surveyor Notes:			N/A	Landing Width (in)	N/A	N/A	DWS Contrast?		
N/A			N/A	Landing Slope (%)	N/A	N/A	DWS Length (in)		
			N/A	Landing X Slope (%)	N/A	N/A	DWS Full Width?		
			N/A	Landing Curb? (Y/N)	N/A	N/A	DWS Offset (in)		
			N/A	Shared Landing?	N/A				
PROW/ADA:			N/A	Gutter Ponding?	N/A	N/A	Gutter Slope (%)		
Not Found, R304.5.1			N/A	Gutter Lip Ht (in)	N/A	N/A	Gutter X Slope (%)		
·			N/A	Painted X Walk1?	Yes	N/A	Painted X Walk2?		
				X Walk 1 Direction	To N		X Walk 2 Direction		
			N/A	X Walk 1 Width (in)	96.0	N/A	X Walk 2 Width (in)		
				X Walk 1 Slope (%)	2.2		X Walk 2 Slope (%)		
				X Walk 1 X Slope (%)	0.1		X Walk 2 X Slope (%)		
			N/A	Ramp inside XWalk1?	Yes	N/A	Ramp inside XWalk2?

Road Slope (%)	N/A	N/A	Clear Space?		
			Clear Space to XWalk (in)						
			N/A	Any Obstructions?	N/A	N/A	Storm Grate/Utility Hazard?		
Total Cost: \$	\$	1850.00		Obstruction Type		l	Storm Grate/Utility Type		
					N/A
