# Access Compliance Report

## Public Rights-of-Way

### (Curb Ramps)

| Intersection ID: 47911 | Main Street: ROOK_RD | Cross Street: RINGNECK_RD | Location: NW |

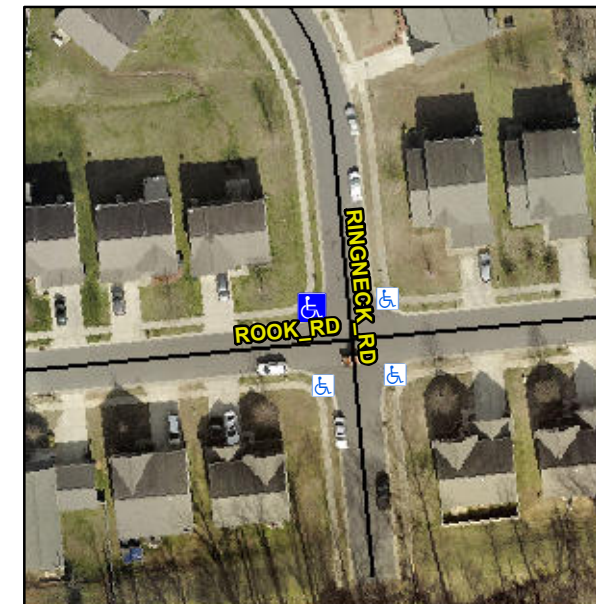
**Not Found, R304.5.3, R304.2.1, R304.2.2-Perp, R304.3.2-Para, R305.2**

| Compliance | Description | Data | Compliance | Description | Data |
|---|---|---|---|---|---|
| Yes | Ramp Width (in) | 48.0 | No | Ramp XSlope (%) | 2.3 |
| No | Landing Length (in) | 46.5 | Yes | DWS Provided? | Yes |
| No | Landing Slope (%) | 3.2 | Yes | DWS Length (in) | 24.0 |
| N/A | Landing Curb? (Y/N) | No | No | DWS Offset (in) | 4.5 |

**Remove & Replace Curb Ramp With Two New Directional Ramps or Equivalent.**

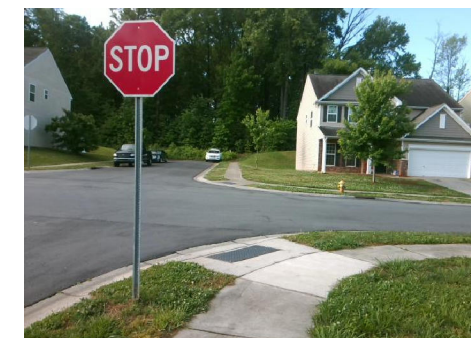
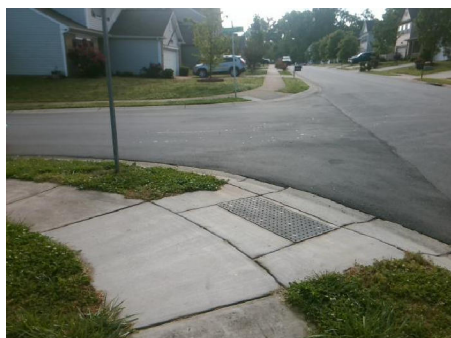
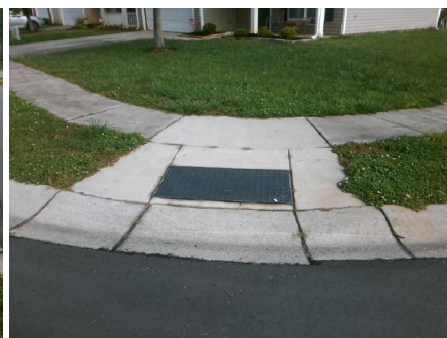
Street 1 Name ROOK RD  
 Stop Condition-Street 2 None  
 Street 2 Name RINGNECK RD  
 Stop Condition-Street 1 StopSign
