# Access Compliance Report

## Public Rights-of-Way

### (Curb Ramps)

Intersection ID: 10022511	Main Street: CARANNA_CT	Cross Street: N/A	Location: NE
ADA ID: 7EE2903DED08	Ramp Type: Perp	Initial Pass/Fail: Fail	Overall Compliance: No
Severity Score: 21.25			
Codes/Mitigation Info/Possible Solution		Field Measurements/Component Compliance

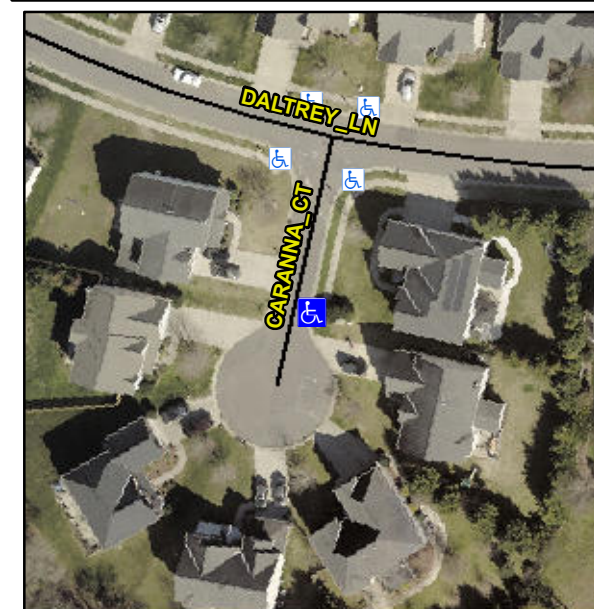
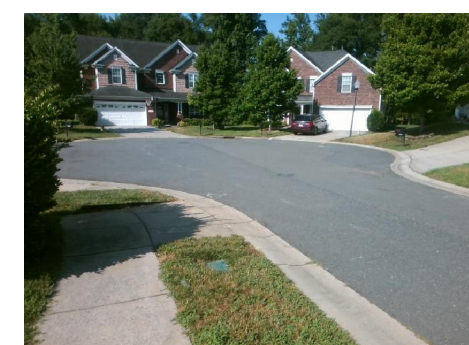
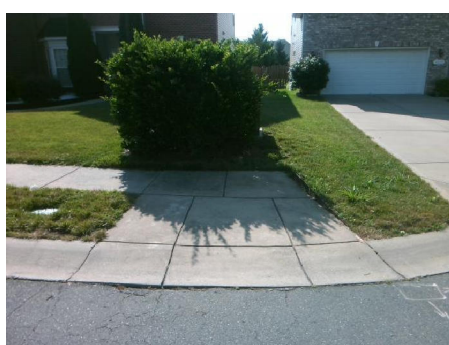
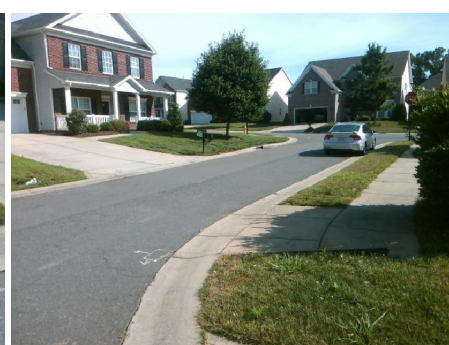
**Not Found, R304.5.1, R304.5.3**

Compliance	Description	Data	Compliance	Description	Data
N/A	Ramp Length (in)	49.0	Yes	Ramp Slope (%)	5.7
No	Ramp Width (in)	41.0	No	Ramp XSlope (%)	6.5
N/A	Flare Type LT	N/A	N/A	Flare Type RT	N/A
N/A	Flare Slope LT (%)	N/A	N/A	Flare Slope RT (%)	N/A
N/A	Flare Traversable LT?	N/A	N/A	Flare Traversable RT?	N/A
N/A	Landing Length (in)	N/A	N/A	DWS Provided?	N/A
N/A	Landing Width (in)	N/A	N/A	DWS Contrast?	N/A
N/A	Landing Slope (%)	N/A	N/A	DWS Length (in)	N/A
N/A	Landing X Slope (%)	N/A	N/A	DWS Full Width?	N/A
N/A	Landing Curb? (Y/N)	N/A	N/A	DWS Offset (in)	N/A
N/A	Shared Landing?	N/A			
N/A	Gutter Ponding?	N/A	N/A	Gutter Slope (%)	N/A
N/A	Gutter Lip Ht (in)	0.5	N/A	Gutter X Slope (%)	N/A
N/A	Painted X Walk1?	No	N/A	Painted X Walk2?	N/A
	X Walk 1 Direction	To NW		X Walk 2 Direction	N/A
N/A	X Walk 1 Width (in)	N/A	N/A	X Walk 2 Width (in)	N/A
	X Walk 1 Slope (%)	1.4		X Walk 2 Slope (%)	N/A
	X Walk 1 X Slope (%)	0.7		X Walk 2 X Slope (%)	N/A

N/A	Ramp inside XWalk1?	N/A	N/A	Ramp inside XWalk2?	N/A
	Road Slope (%)	N/A	N/A	Clear Space?	N/A
	Road X Slope (%)	N/A	N/A	Clear Space to XWalk (in)	N/A
N/A	Any Obstructions?	N/A	N/A	Storm Grate/Utility Hazard?	N/A
	Obstruction Type			Storm Grate/Utility Type	
		N/A			N/A
		Yes		Surface Condition? (G/P)	Good

**Remove & Replace Entire Ramp.**

Total Cost: \$ 1850.00
