# Access Compliance Report

## Public Rights-of-Way

### (Curb Ramps)

Intersection ID: 10396	Main Street: DADE_ST	Cross Street: THE_PLAZA	Location: E
ADA ID: 7EFD7F10D088	Ramp Type: Perp	Initial Pass/Fail: Fail	Overall Compliance: No
			Severity Score: 21.25

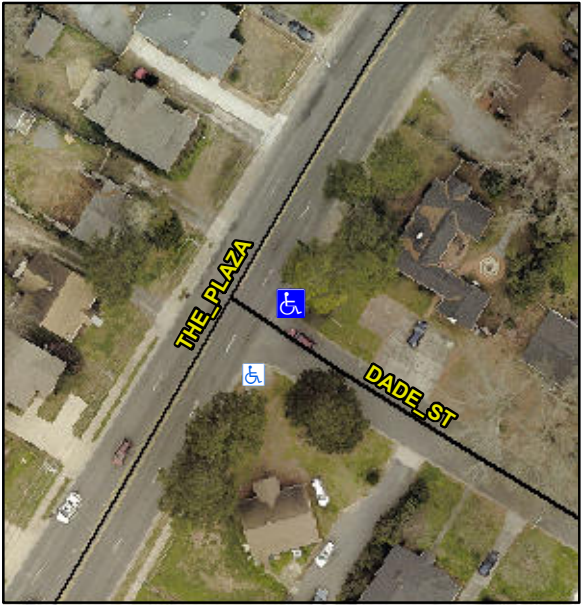
Possible Solutions:		<b>Compliance</b>	<b>Description</b>	<b>Data</b>
	<b>Remove &amp; Replace Entire Ramp.</b>		<b>Yes</b>	Ramp Slope (%)	7.9
			<b>No</b>	Ramp XSlope (%)	6.7
			<b>N/A</b>	Flare Type LT	N/A
			<b>N/A</b>	Flare Slope LT (%)	N/A
			<b>N/A</b>	Flare Traversable LT?	N/A
			<b>N/A</b>	Landing Length (in)	N/A
			<b>N/A</b>	Landing Width (in)	N/A
			<b>N/A</b>	Landing Slope (%)	N/A
			<b>N/A</b>	Landing X Slope (%)	N/A
<p>Surveyor Notes:</p> <p><b>N/A</b></p>			<b>N/A</b>	Landing Curb? (Y/N)	N/A
			<b>N/A</b>	Shared Landing?	N/A
			<b>N/A</b>	Gutter Ponding?	N/A
			<b>N/A</b>	Gutter Lip Ht (in)	0.5
			<b>N/A</b>	Painted X Walk1?	No
				X Walk 1 Direction	To SW
			<b>N/A</b>	X Walk 1 Width (in)	N/A
				X Walk 1 Slope (%)	0.2
				X Walk 1 X Slope (%)	5.5
			<b>N/A</b>	Ramp inside XWalk1?	N/A
<p>PROW/ADA:</p> <p><b>R304.5.1, R304.5.3</b></p>			<b>N/A</b>	Road Slope (%)	N/A

<b>N/A</b>	Road X Slope (%)	N/A
			<b>N/A</b>	Any Obstructions?	N/A
				Obstruction Type	
			<b>N/A</b>		
			<b>N/A</b>		
			<b>N/A</b>		
			<b>N/A</b>		
			<b>N/A</b>		
			<b>N/A</b>		
<p>Total Cost:</p> <p><b>\$ 1850.00</b></p>			<b>N/A</b>	Clear Space?	N/A
			<b>N/A</b>	Clear Space to XWalk (in)	N/A
			<b>N/A</b>	Storm Grate/Utility Hazard?	N/A
				Storm Grate/Utility Type	
			<b>N/A</b>		
			<b>N/A</b>		
			<b>N/A</b>		
			<b>N/A</b>		
			<b>N/A</b>		
			<b>N/A</b>		
<p>Street 1 Name</p> <p><b>DADE ST</b></p> <p>Stop Condition-Street 2</p> <p><b>StopSign</b></p> <p>Street 2 Name</p> <p><b>N/A</b></p> <p>Stop Condition-Street 1</p> <p><b>N/A</b></p>			<b>Yes</b>	Surface Condition? (G/P)	Good
