Access Compliance Report Public Rights-of-Way (Curb Ramps)

Intersection ID: 18778 Main Street: E_INDEPENDENCE_BV Cross Street: E_W_T_HARRIS_BV Location: W

ADA ID: 7EFEF356F6A1 Ramp Type: IslandPerp Initial Pass/Fail: Fail Overall Compliance: No Severity Score: 1.25

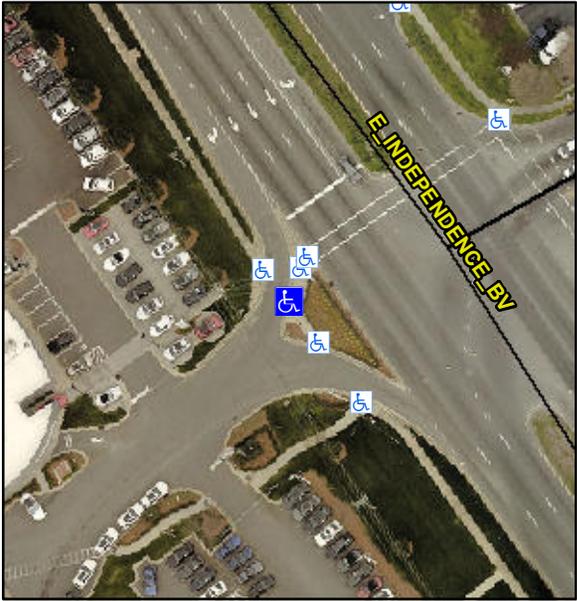
PROW/ADA:
Not Found, R304.5.3

Compliance	Description	Data	Compliance	Description	Data
N/A	Ramp Length (in)	88.0	Yes	Ramp Slope (%)	5.5
Yes	Ramp Width (in)	48.0	No	Ramp XSlope (%)	4.0
N/A	Flare Type LT	N/A	N/A	Flare Type RT	N/A
N/A	Flare Slope LT (%)	N/A	N/A	Flare Slope RT (%)	N/A
N/A	Flare Traversable LT?	N/A	N/A	Flare Traversable RT?	N/A
N/A	Landing Length (in)	N/A	N/A	DWS Provided?	N/A
N/A	Landing Width (in)	N/A	N/A	DWS Contrast?	N/A
N/A	Landing Slope (%)	N/A	N/A	DWS Length (in)	N/A
N/A	Landing X Slope (%)	N/A	N/A	DWS Full Width?	N/A
N/A	Landing Curb? (Y/N)	N/A	N/A	DWS Offset (in)	N/A
N/A	Shared Landing?	N/A			
N/A	Gutter Ponding?	N/A	N/A	Gutter Slope (%)	N/A
N/A	Gutter Lip Ht (in)	N/A	N/A	Gutter X Slope (%)	N/A
N/A	Painted X Walk1?	No	N/A	Painted X Walk2?	N/A
	X Walk 1 Direction	To NW		X Walk 2 Direction	N/A
N/A	X Walk 1 Width (in)	N/A	N/A	X Walk 2 Width (in)	N/A
	X Walk 1 Slope (%)	2.7		X Walk 2 Slope (%)	N/A
	X Walk 1 X Slope (%)	1.6		X Walk 2 X Slope (%)	N/A

N/A	Ramp inside XWalk1?	N/A	N/A	Ramp inside XWalk2?	N/A
	Road Slope (%)	N/A	N/A	Clear Space?	N/A
	Road X Slope (%)	N/A	N/A	Clear Space to XWalk (in)	N/A
N/A	Any Obstructions?	N/A	N/A	Storm Grate/Utility Hazard?	N/A
	Obstruction Type			Storm Grate/Utility Type	
		N/A			N/A
Yes	Surface Condition? (G/P)				Good

Possible Solutions:
Remove & Replace Entire Ramp.

Total Cost: \$ **3400.00**
