Access Compliance Report Public Rights-of-Way (Curb Ramps)

Intersection ID: 6739 Main Street: CARRIAGE OAKS DR Cross Street: N/A Location: W Initial Pass/Fail: Fail **Overall Compliance: No** ADA ID: 7F08830FD109 Ramp Type: Combination1 Severity Score: 46.25

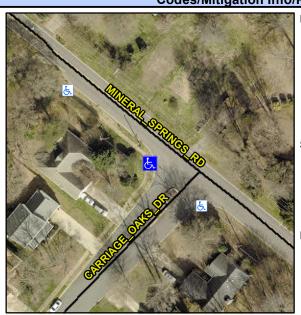
Street 1 Name None Stop Condition-Street 1 CARRIAGE OAKS DR Street 2 Name N/A Stop Condition-Street 2 N/A Possible Solutions: Remove & Replace Entire Ramp. Surveyor Notes: LT RP < 5% PROW/ADA: R304.5.1, R304.2.2, R304.5.3, R304.3.2
