Access Compliance Report

Public Rights-of-Way

(Curb Ramps)

Intersection ID: N/A	Main Street: DALLAS_BAY_RD	Cross Street: HAMILTON_BRIDGE_RD	Location: SE
ADA ID: 7F14962B06AB	Ramp Type: Perp	Initial Pass/Fail: Fail	Overall Compliance: No
			Severity Score: 21.25

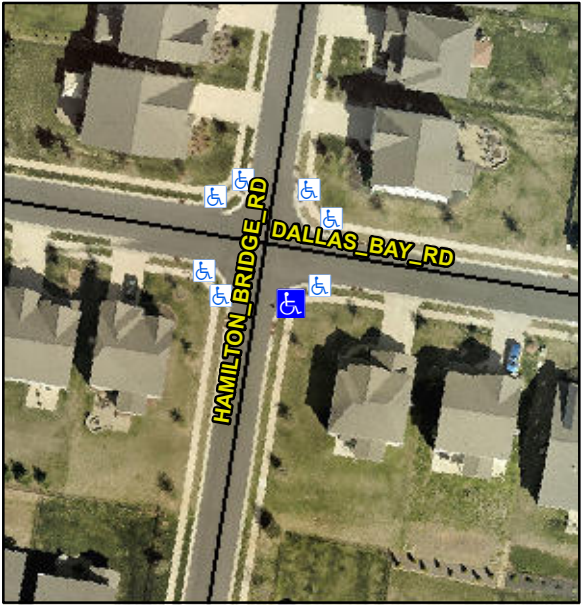
Compliance	Description	Data	Compliance	Description	Data
N/A	Ramp Length (in)	45.0	No	Ramp Slope (%)	10.0
No	Ramp Width (in)	47.5	Yes	Ramp XSlope (%)	0.8
N/A	Flare Type LT	N/A	N/A	Flare Type RT	N/A
N/A	Flare Slope LT (%)	N/A	N/A	Flare Slope RT (%)	N/A
N/A	Flare Traversable LT?	N/A	N/A	Flare Traversable RT?	N/A
N/A	Landing Length (in)	N/A	N/A	DWS Provided?	N/A
N/A	Landing Width (in)	N/A	N/A	DWS Contrast?	N/A
N/A	Landing Slope (%)	N/A	N/A	DWS Length (in)	N/A
N/A	Landing X Slope (%)	N/A	N/A	DWS Full Width?	N/A
N/A	Landing Curb? (Y/N)	N/A	N/A	DWS Offset (in)	N/A
N/A	Shared Landing?	N/A			
N/A	Gutter Ponding?	N/A	N/A	Gutter Slope (%)	N/A
N/A	Gutter Lip Ht (in)	1.0	N/A	Gutter X Slope (%)	N/A
N/A	Painted X Walk1?	No	N/A	Painted X Walk2?	N/A
	X Walk 1 Direction	To W		X Walk 2 Direction	N/A
N/A	X Walk 1 Width (in)	N/A	N/A	X Walk 2 Width (in)	N/A
	X Walk 1 Slope (%)	4.1		X Walk 2 Slope (%)	N/A
	X Walk 1 X Slope (%)	1.6		X Walk 2 X Slope (%)	N/A

N/A	Ramp inside XWalk1?	N/A	N/A	Ramp inside XWalk2?	N/A
	Road Slope (%)	N/A	N/A	Clear Space?	N/A
	Road X Slope (%)	N/A	N/A	Clear Space to XWalk (in)	N/A
N/A	Any Obstructions?	N/A	N/A	Storm Grate/Utility Hazard?	N/A
	Obstruction Type			Storm Grate/Utility Type	
		N/A			N/A
			Yes	Surface Condition? (G/P)	Good

<p>Possible Solutions:</p> <p>Remove & Replace Entire Ramp.</p>	<p>Surveyor Notes:</p> <p>N/A</p>	<p>PROW/ADA:</p> <p>Not Found, R304.5.1, R304.2.2</p>		
Street 1 Name	HAMILTON BRIDGE RD				
Stop Condition-Street 2	StopSign				
Street 2 Name	N/A				
Stop Condition-Street 1	N/A				
Total Cost:		\$	1850.00
