# Access Compliance Report

## Public Rights-of-Way

### (Curb Ramps)

Intersection ID: 5097	Main Street: CARDINGTON_CT	Cross Street: PENNYCROSS_LN	Location: SW
ADA ID: 7F1EA5362F32	Ramp Type: Perp	Initial Pass/Fail: Fail	Overall Compliance: No
Severity Score: 12.5			
Codes/Mitigation Info/Possible Solution		Field Measurements/Component Compliance

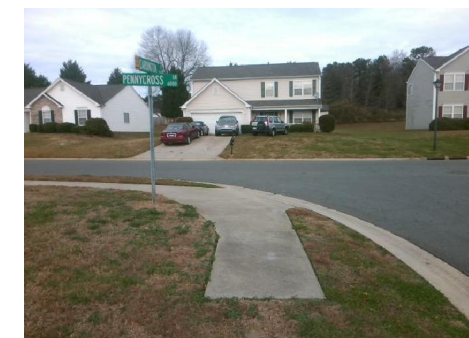
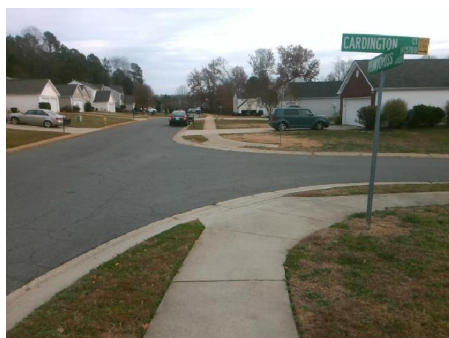
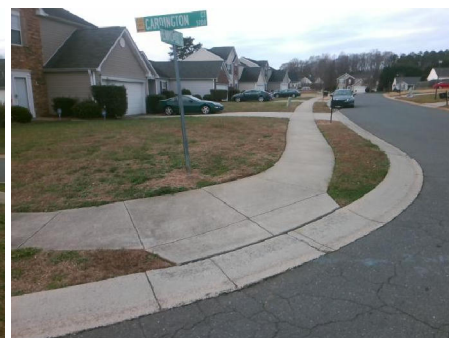
**Not Found, R304.5.3**

Compliance	Description	Data	Compliance	Description	Data
N/A	Ramp Length (in)	57.0	Yes	Ramp Slope (%)	7.6
Yes	Ramp Width (in)	48.0	No	Ramp XSlope (%)	5.2
N/A	Flare Type LT	N/A	N/A	Flare Type RT	N/A
N/A	Flare Slope LT (%)	N/A	N/A	Flare Slope RT (%)	N/A
N/A	Flare Traversable LT?	N/A	N/A	Flare Traversable RT?	N/A
N/A	Landing Length (in)	N/A	N/A	DWS Provided?	N/A
N/A	Landing Width (in)	N/A	N/A	DWS Contrast?	N/A
N/A	Landing Slope (%)	N/A	N/A	DWS Length (in)	N/A
N/A	Landing X Slope (%)	N/A	N/A	DWS Full Width?	N/A
N/A	Landing Curb? (Y/N)	N/A	N/A	DWS Offset (in)	N/A
N/A	Shared Landing?	N/A			
N/A	Gutter Ponding?	N/A	N/A	Gutter Slope (%)	N/A
N/A	Gutter Lip Ht (in)	N/A	N/A	Gutter X Slope (%)	N/A
N/A	Painted X Walk1?	No	N/A	Painted X Walk2?	N/A
	X Walk 1 Direction	To E		X Walk 2 Direction	N/A
N/A	X Walk 1 Width (in)	N/A	N/A	X Walk 2 Width (in)	N/A
	X Walk 1 Slope (%)	1.5		X Walk 2 Slope (%)	N/A
	X Walk 1 X Slope (%)	4.7		X Walk 2 X Slope (%)	N/A

N/A	Ramp inside XWalk1?	N/A	N/A	Ramp inside XWalk2?	N/A
	Road Slope (%)	N/A	N/A	Clear Space?	N/A
	Road X Slope (%)	N/A	N/A	Clear Space to XWalk (in)	N/A
N/A	Any Obstructions?	N/A	N/A	Storm Grate/Utility Hazard?	N/A
	Obstruction Type			Storm Grate/Utility Type	
		N/A			N/A
		Yes		Surface Condition? (G/P)	Good

**Remove & Replace Entire Ramp.**
