# Access Compliance Report

## Public Rights-of-Way

### (Curb Ramps)

Intersection ID: 8890	Main Street: BEATTIES_FORD_RD	Cross Street: RUSSELL_AV	Location: SE
ADA ID: 7F332DA0C853	Ramp Type: PerpDiag	Initial Pass/Fail: Fail	Overall Compliance: No
Codes/Mitigation Info/Possible Solution		Field Measurements/Component Compliance

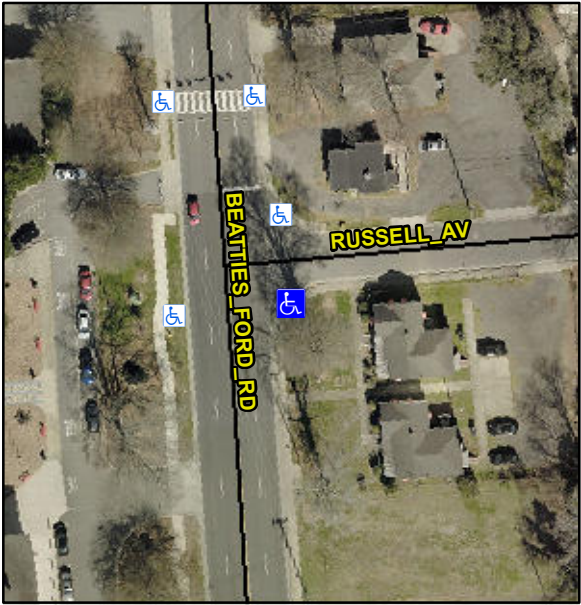
Possible Solutions:	Compliance	Description	Data	Compliance	Description	Data
	Remove & Replace Curb Ramp With Two New Directional Ramps or Equivalent.	N/A	Ramp Length (in)	55.0	Yes	Ramp Slope (%)	7.3
<p>Surveyor Notes:</p> <p>N/A</p> <p>PROW/ADA:</p> <p>Not Found, R304.5.1, R304.5.3</p>		No	Ramp Width (in)	41.5	No	Ramp XSlope (%)	5.3
		N/A	Flare Type LT	N/A	N/A	Flare Type RT	N/A
		N/A	Flare Slope LT (%)	N/A	N/A	Flare Slope RT (%)	N/A
		N/A	Flare Traversable LT?	N/A	N/A	Flare Traversable RT?	N/A
		N/A	Landing Length (in)	N/A	N/A	DWS Provided?	N/A
		N/A	Landing Width (in)	N/A	N/A	DWS Contrast?	N/A
		N/A	Landing Slope (%)	N/A	N/A	DWS Length (in)	N/A
		N/A	Landing X Slope (%)	N/A	N/A	DWS Full Width?	N/A
		N/A	Landing Curb? (Y/N)	N/A	N/A	DWS Offset (in)	N/A
		N/A	Shared Landing?	N/A			
		N/A	Gutter Ponding?	N/A	N/A	Gutter Slope (%)	N/A
		N/A	Gutter Lip Ht (in)	0.5	N/A	Gutter X Slope (%)	N/A
		N/A	Painted X Walk1?	No	N/A	Painted X Walk2?	No

X Walk 1 Direction	To N		X Walk 2 Direction	To W
		N/A	X Walk 1 Width (in)	N/A	N/A	X Walk 2 Width (in)	N/A
			X Walk 1 Slope (%)	2.1		X Walk 2 Slope (%)	5.0
			X Walk 1 X Slope (%)	5.1		X Walk 2 X Slope (%)	0.5
		N/A	Ramp inside XWalk1?	N/A	N/A	Ramp inside XWalk2?	N/A
			Road Slope (%)	2.3	N/A	Clear Space?	N/A
			Road X Slope (%)	7.3	N/A	Clear Space to XWalk (in)	N/A
		N/A	Any Obstructions?	N/A	N/A	Storm Grate/Utility Hazard?	N/A
			Obstruction Type			Storm Grate/Utility Type	
					N/A		N/A
					Yes	Surface Condition? (G/P)	Good
