Access Compliance Report Public Rights-of-Way (Curb Ramps)

Intersection ID: 2754	tersection ID: 2754 Main Street: KINGLET_LN C					Cross Street: WINGMONT_DR				
								Location:	<u>E</u>	
ADA ID: 7F33529DE379 Ramp Type: PerpDiag		Initial P	Initial Pass/Fail: Fail Overall Compliance: No				o Severity Score:	12.5		
Codes/Mitigation Info/Possible Solution				Field Measurements/Component Compliance

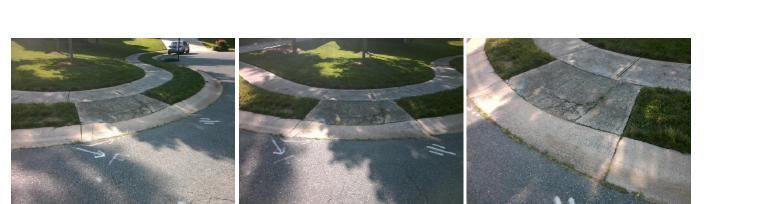
S. S.	Possible Solutions:		Compliance Description			Data Compliance Description			
		Remove & Replace Curb Ramp V	Vith	N/A	Ramp Length (in)	47.0	No	Ramp Slope (%)	8.9	
		Two New Directional Ramps or Equivalent.		Yes	Ramp Width (in)	48.0	Yes	Ramp XSlope (%)	1.4	
				N/A	Flare Type LT	N/A	N/A	Flare Type RT	N/A	
				N/A	Flare Slope LT (%)	N/A	N/A	Flare Slope RT (%)	N/A	
				N/A	Flare Traversable LT?	N/A	N/A	Flare Traversable RT?	N/A	
				N/A	Landing Length (in)	N/A	N/A	DWS Provided?	N/A	
12/2 & VIA		Surveyor Notes:		N/A	Landing Width (in)	N/A	N/A	DWS Contrast?	N/A	
the second se	A 1	N/A		N/A	Landing Slope (%)	N/A	N/A	DWS Length (in)	N/A	
a la la				N/A	Landing X Slope (%)	N/A	N/A	DWS Full Width?	N/A	
10			N/A	Landing Curb? (Y/N)	N/A	N/A	DWS Offset (in)	N/A		
			N/A	Shared Landing?	N/A
