# Access Compliance Report

## Public Rights-of-Way

### (Curb Ramps)

| ADA ID: 7F3F24FF8F17 | Ramp Type: Perp | Initial Pass/Fail: Fail | Overall Compliance: No | Severity Score: 12.5 |

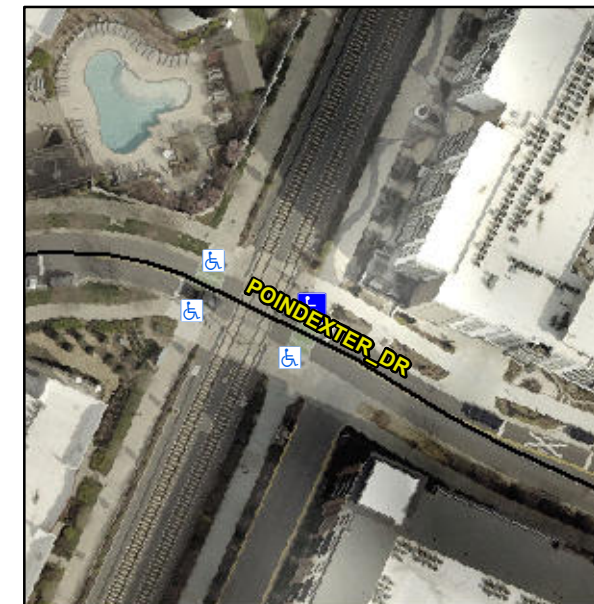
**Not Found, R304.2.2**

| Compliance | Description | Data | Compliance | Description | Data |
|---|---|---|---|---|---|
| N/A | Ramp Length (in) | 66.0 | No | Ramp Slope (%) | 9.2 |

**Remove & Replace Entire Ramp.**

Total Cost: \$ 1850.00
