Access Compliance Report

Public Rights-of-Way

(Curb Ramps)

Intersection ID: N/A	Main Street: LADY LIBERTY LN	Cross Street: TANYARD LN	Location: S
ADA ID: 7F5F75694E48	Ramp Type: PerpDiag	Initial Pass/Fail: Fail	Overall Compliance: No
			Severity Score: 21.25

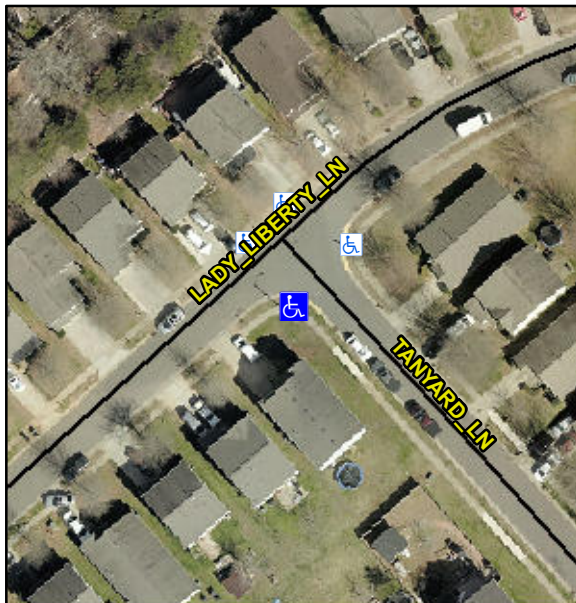
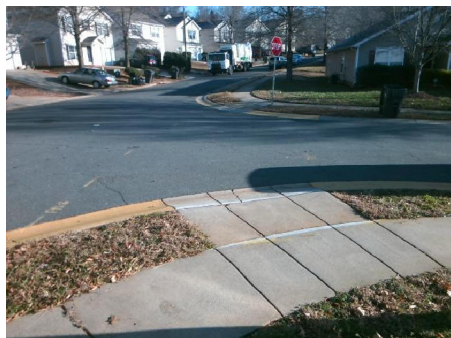
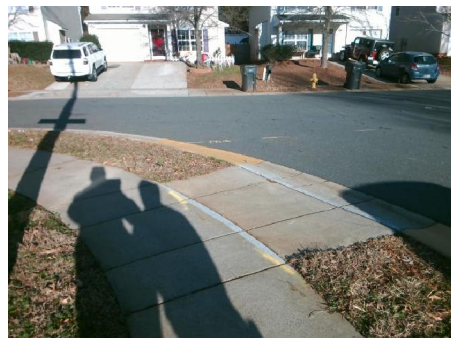
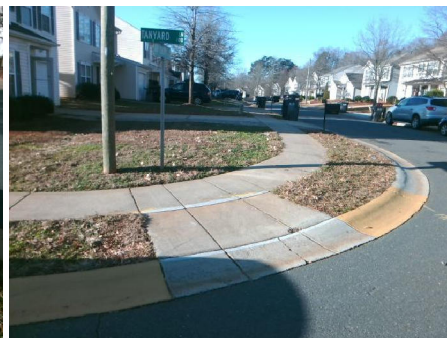
Not Found, R304.5.1, R304.5.3

Compliance	Description	Data	Compliance	Description	Data
N/A	Ramp Length (in)	49.0	Yes	Ramp Slope (%)	7.0
No	Ramp Width (in)	36.0	No	Ramp XSlope (%)	5.6
N/A	Flare Type LT	N/A	N/A	Flare Type RT	N/A
N/A	Flare Slope LT (%)	N/A	N/A	Flare Slope RT (%)	N/A
N/A	Flare Traversable LT?	No	N/A	Flare Traversable RT?	No
N/A	Landing Length (in)	N/A	N/A	DWS Provided?	N/A
N/A	Landing Width (in)	N/A	N/A	DWS Contrast?	N/A
N/A	Landing Slope (%)	N/A	N/A	DWS Length (in)	N/A
N/A	Landing X Slope (%)	N/A	N/A	DWS Full Width?	N/A
N/A	Landing Curb? (Y/N)	N/A	N/A	DWS Offset (in)	N/A
N/A	Shared Landing?	N/A			
N/A	Gutter Ponding?	N/A	N/A	Gutter Slope (%)	N/A
N/A	Gutter Lip Ht (in)	N/A	N/A	Gutter X Slope (%)	N/A
N/A	Painted X Walk1?	No	N/A	Painted X Walk2?	No
	X Walk 1 Direction	To NE		X Walk 2 Direction	To NW
N/A	X Walk 1 Width (in)	N/A	N/A	X Walk 2 Width (in)	N/A
	X Walk 1 Slope (%)	1.4		X Walk 2 Slope (%)	5.4
	X Walk 1 X Slope (%)	4.6		X Walk 2 X Slope (%)	0.2

N/A	Ramp inside XWalk1?	No	N/A	Ramp inside XWalk2?	No
	Road Slope (%)	4.2	N/A	Clear Space?	N/A
	Road X Slope (%)	3.7	N/A	Clear Space to XWalk (in)	N/A
N/A	Any Obstructions?	N/A	N/A	Storm Grate/Utility Hazard?	N/A
	Obstruction Type			Storm Grate/Utility Type	
		N/A			N/A
			Yes	Surface Condition? (G/P)	Good

Remove & Replace Curb Ramp With Two New Directional Ramps or Equivalent.
