Access Compliance Report

Public Rights-of-Way

(Curb Ramps)

Intersection ID: 11546	Main Street: HEYWOOD_AV	Cross Street: KEMPTON_PL	Location: W
ADA ID: 7F64E6E8DA3F	Ramp Type: BlendTrans1	Initial Pass/Fail: Fail	Overall Compliance: No
Severity Score: 1.25			
Codes/Mitigation Info/Possible Solution		Field Measurements/Component Compliance

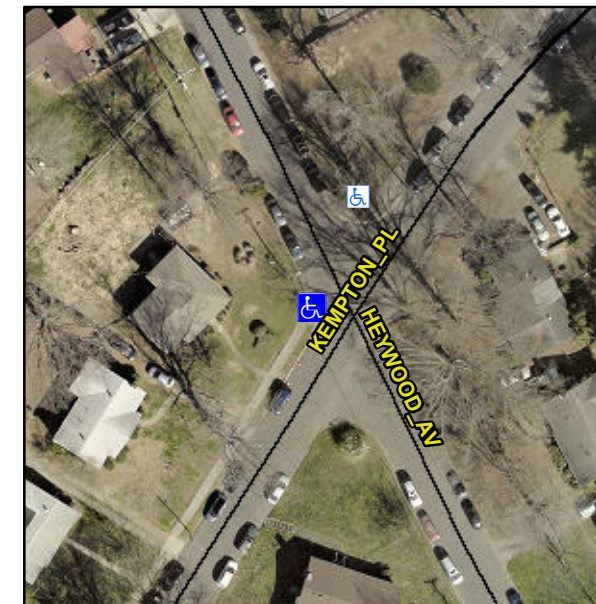
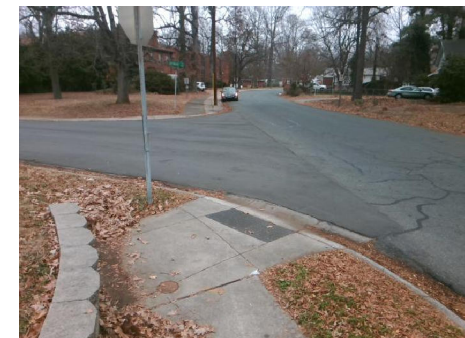
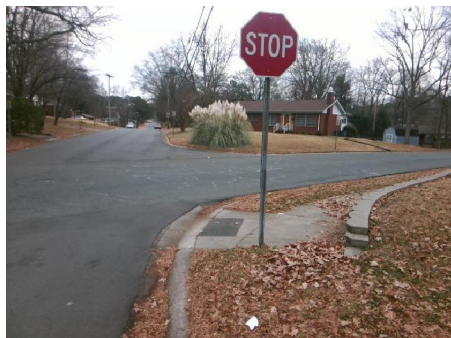
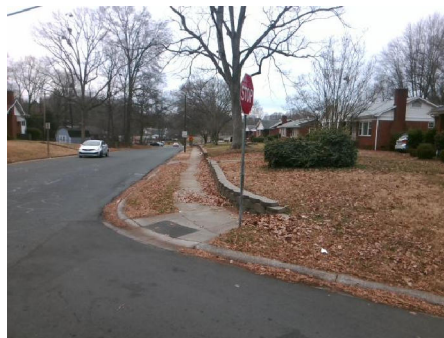
Not Found, R304.5.3

Compliance	Description	Data	Compliance	Description	Data
N/A	Ramp Length (in)	30.0	Yes	BlendTrans Slope (%)	4.2
Yes	Ramp Width (in)	48.0	No	BlendTrans XSlope (%)	3.5
N/A	Flare Type LT	N/A	N/A	Flare Type RT	N/A
N/A	Flare Slope LT (%)	N/A	N/A	Flare Slope RT (%)	N/A
N/A	Flare Traversable LT?	N/A	N/A	Flare Traversable RT?	N/A
N/A	Landing Length (in)	N/A	N/A	DWS Provided?	N/A
N/A	Landing Width (in)	N/A	N/A	DWS Contrast?	N/A
N/A	Landing Slope (%)	N/A	N/A	DWS Length (in)	N/A
N/A	Landing X Slope (%)	N/A	N/A	DWS Full Width?	N/A
N/A	Landing Curb? (Y/N)	N/A	N/A	DWS Offset (in)	N/A
N/A	Shared Landing?	N/A			
N/A	Gutter Ponding?	N/A	N/A	Gutter Slope (%)	N/A
N/A	Gutter Lip Ht (in)	N/A	N/A	Gutter X Slope (%)	N/A
N/A	Painted X Walk1?	No	N/A	Painted X Walk2?	N/A
	X Walk 1 Direction	To NE		X Walk 2 Direction	N/A
	X Walk 1 Width (in)	N/A		X Walk 2 Width (in)	N/A
	X Walk 1 Slope (%)	1.4		X Walk 2 Slope (%)	N/A
	X Walk 1 X Slope (%)	2.3		X Walk 2 X Slope (%)	N/A

N/A	Ramp inside XWalk1?	N/A	N/A	Ramp inside XWalk2?	N/A
	Road Slope (%)	2.3		Clear Space?	N/A
	Road X Slope (%)	1.4	N/A	Clear Space to XWalk (in)	N/A
N/A	Any Obstructions?	N/A	N/A	Storm Grate/Utility Hazard?	N/A
	Obstruction Type			Storm Grate/Utility Type	
		N/A			N/A
			Yes	Surface Condition? (G/P)	Good
			No	Curb Slope (%)	8.0

Possible Solutions:

Remove & Replace Curb Ramp With Two New Directional Ramps or Equivalent.
