Access Compliance Report

Public Rights-of-Way (Curb Ramps)

Intersection ID: 17486	Main Street: SELWYN_AV	Cross Street: STERLING_RD	Location: W
ADA ID: 7F694F92C119	Ramp Type: Directional1	Initial Pass/Fail: Fail	Overall Compliance: No
Codes/Mitigation Info/Possible Solution		Field Measurements/Component Compliance	
Severity Score: 1.25

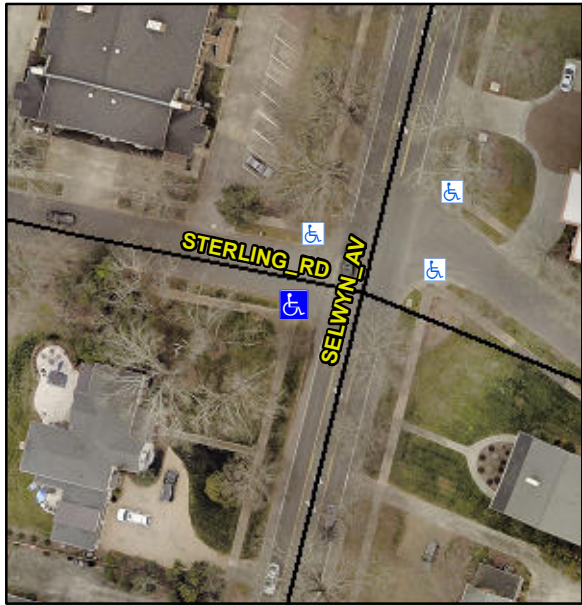
Compliance	Description	Data	Compliance	Description	Data
N/A	Ramp Length (in)	82.0	N/A	Grade Break?	N/A
Yes	Ramp Width (in)	60.0	N/A	Grade Break Slope (%)	0.0
Yes	Ramp Slope (%)	1.5	N/A	Grade Break XSlope (%)	0.0
No	Ramp XSlope (%)	2.6			
N/A	Flare Type LT	N/A	N/A	Flare Type RT	N/A
N/A	Flare Slope LT (%)	N/A	N/A	Flare Slope RT (%)	0.0
N/A	Flare Traversable LT?	N/A	N/A	Flare Traversable RT?	N/A
N/A	Landing Length (in)	0.0	N/A	DWS Provided?	N/A
N/A	Landing Width (in)	0.0	N/A	DWS Contrast?	N/A
N/A	Landing Slope (%)	0.0	N/A	DWS Length (in)	N/A
N/A	Landing X Slope (%)	0.0	N/A	DWS Full Width?	N/A
N/A	Landing Curb? (Y/N)	N/A	N/A	DWS Offset LT (in)	N/A
N/A	Shared Landing?	N/A	N/A	DWS Offset RT (in)	N/A
N/A	Gutter Ponding?	0.0	N/A	Gutter Slope (%)	N/A
N/A	Gutter Lip Ht (in)	0.0	N/A	Gutter X Slope (%)	N/A
N/A	Painted X Walk1?	No		Road Slope (%)	0.6
	X Walk 1 Direction	To N		Road X Slope (%)	3.0
	X Walk 1 Width (in)	N/A		Clear Space?	N/A

X Walk 1 Slope (%)	0.6	N/A	Clear Space to XWalk (in)	N/A
	X Walk 1 X Slope (%)	3.0	N/A	Storm Grate/Utility Hazard?	N/A
N/A	Ramp inside XWalk1?	N/A		Storm Grate/Utility Type	
N/A	Any Obstructions?	N/A			N/A
	Obstruction Type		Yes	Surface Condition? (G/P)	Good
		N/A	N/A	Curb Slope (%)	8.7

Possible Solutions:

Remove & Replace Entire Ramp.

PROW/ADA:

R304.5.3
